A PRESERVATION PLAN FOR  
FORT SELKIRK

JOHN KEAY, ARCHITECT  
ROBERT PATTERSON, P ENG.

JANUARY, 1992

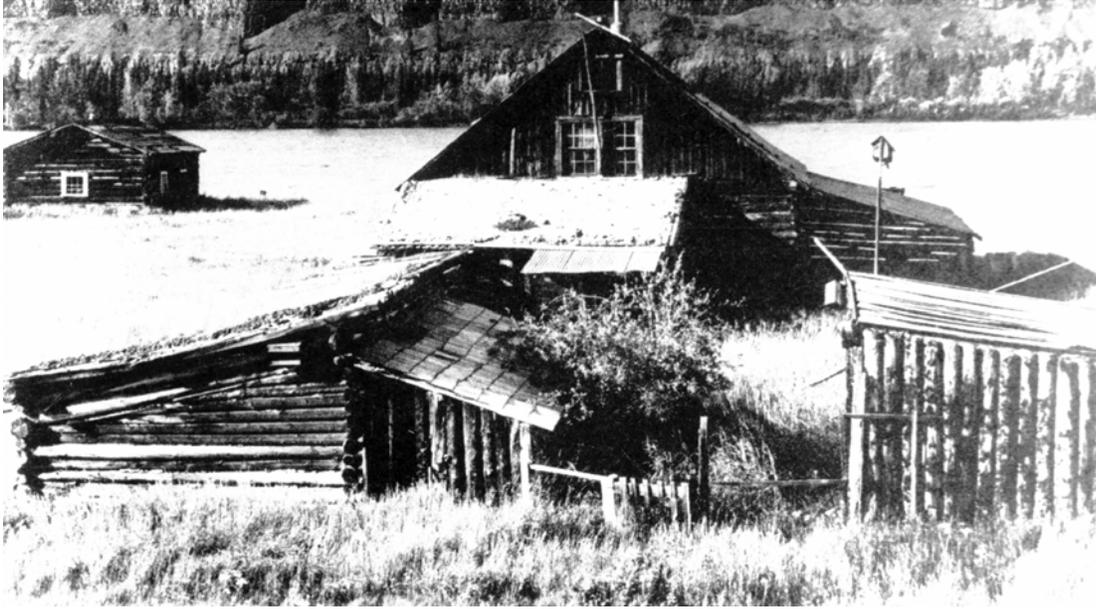
12. Taylor and Drury store and outbuildings, 1964. The lean-to addition to the barn has since been demolished, and the sod roof on the rear of the store has been replaced with roll roofing.

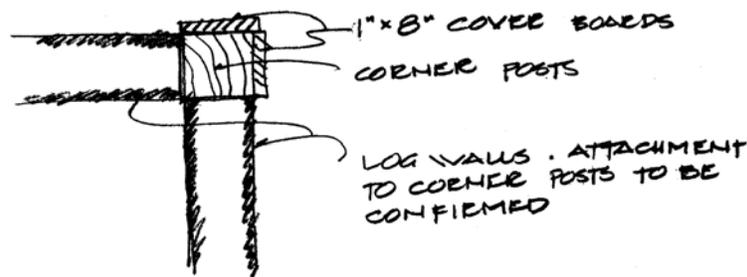
Detail of corner construction - log attachment should be confirmed by removing typical cover board.

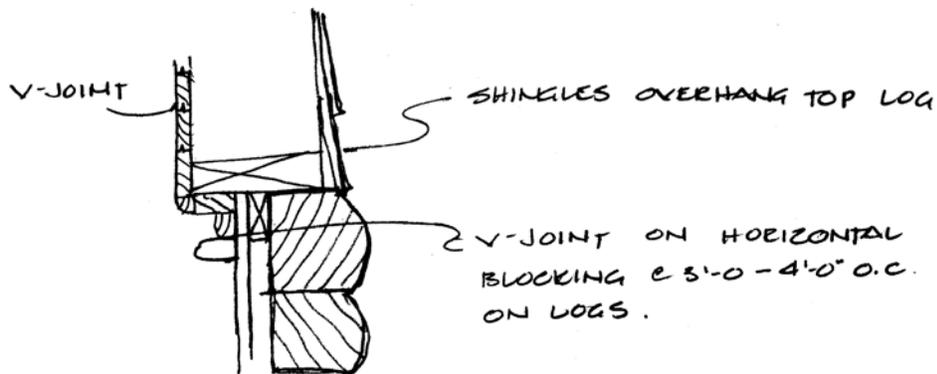
North wall construction not typical.

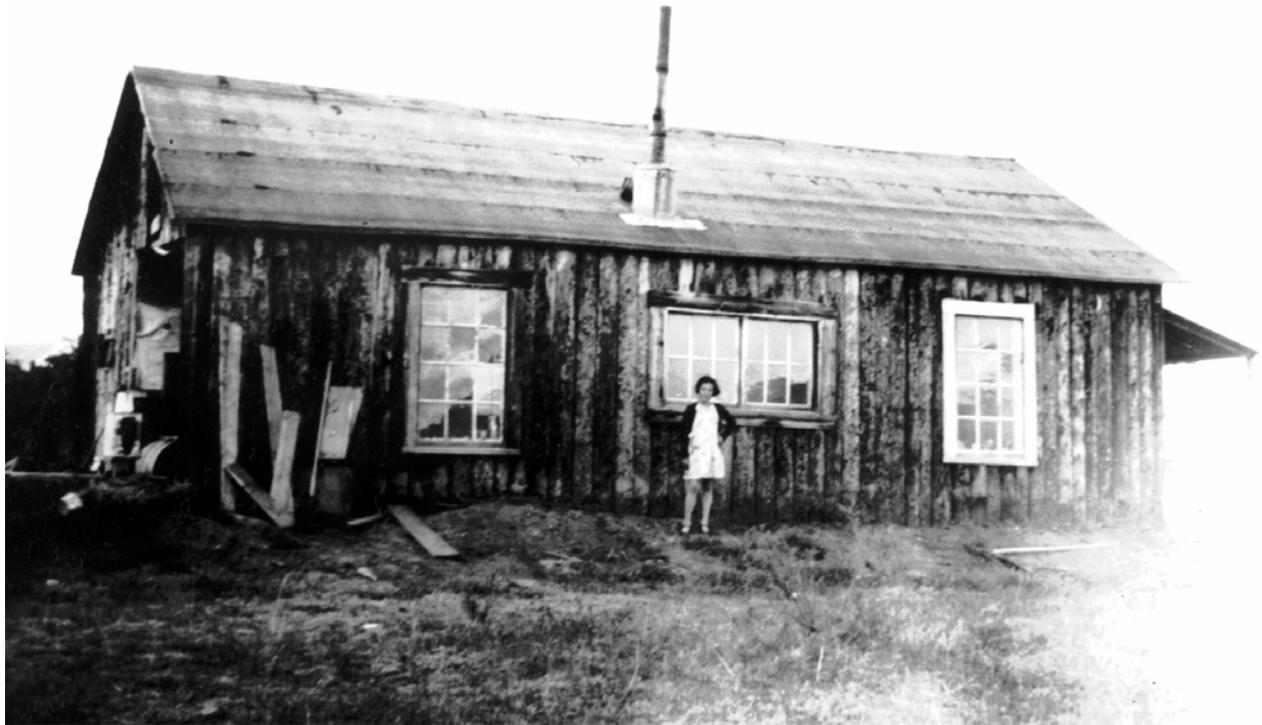
21. Adami (Wilkinson) cabin, ca 1949, Adami Coll. Lightly constructed of framing lumber, lined with v-joint panelling on the interior and vertical slabs on the exterior, the structure requires complete rebuilding.

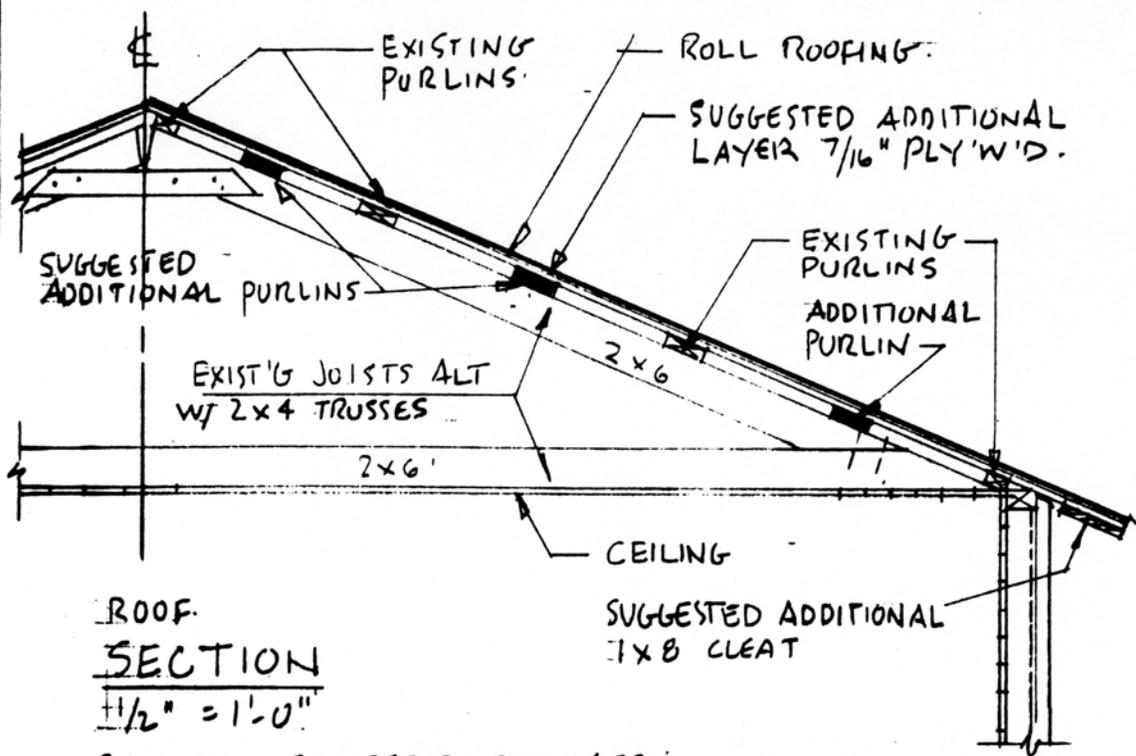
ROOF SECTION  
1/2" = 1'-0"

SHOWING SUGGESTED CHANGES

- increase the number of purlins and improve fastenings, for example by using clenched or ring nails

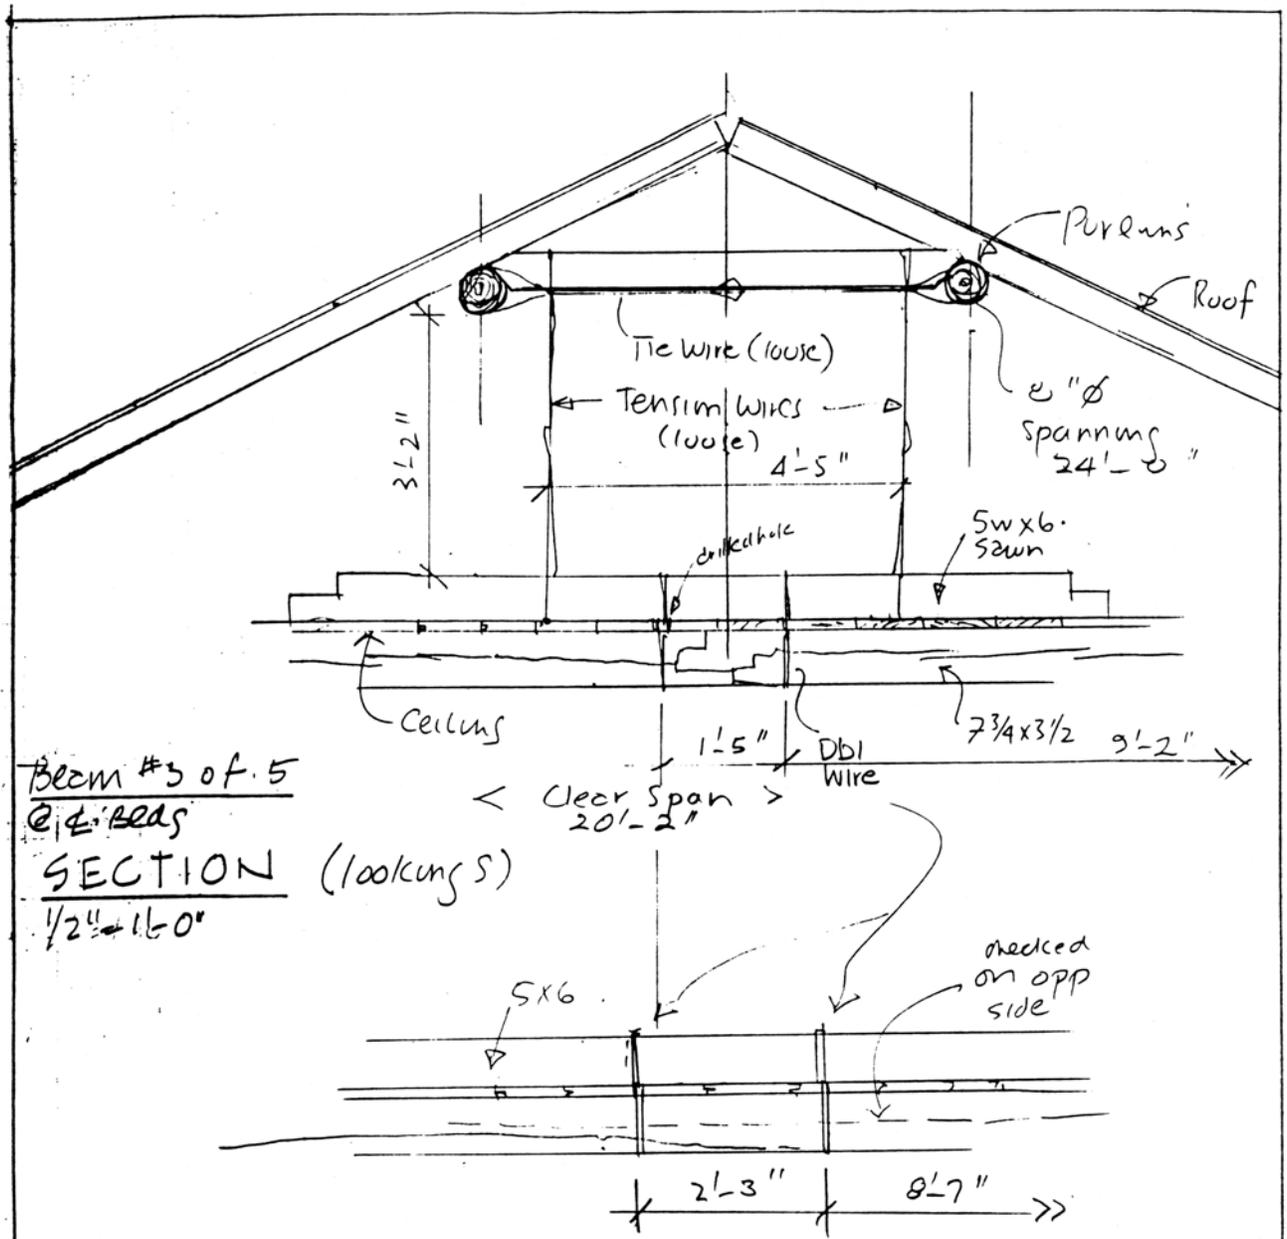
Beam #3 of 5  
 @ 4' BEAS  
 SECTION (looking S)  
 1/2" = 160"

Signs of structural distress were noted in two of the five ceiling beams. The third beam from the south wall is cracked vertically through its entire thickness, and long cracks extend out parallel to the wood grain. The fifth beam is less damaged but shows cracking parallel to the grain and running out to the bottom face. The damage is indicative of heavy superimposed loads on these beams in the past. Both beams have been reinforced with (telegraph) wire ties around the beams and in the case of the third beam, with suspension wires from the roof above (see sketch). Structurally, these repairs are adequate and any effort to improve them visually is likely to worsen the situation structurally. If and when the roof structure is rebuilt, we would recommend replacement of these beams. We would also recommend that all ceiling beams be fastened to the top wall log with vertical drift pins to produce a tying action, which is necessary for the overall strength of the roof.
