Alsek River Watershed - Lakes

- **Titl'at M̄n (Dezadeash Lake)**
- **Kloo Lake**
- **Łu Gha M̄n (Klukshu Lake)**
- **Pine Lake 2**

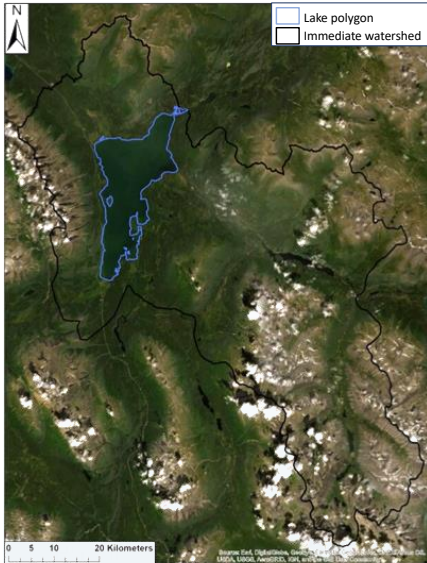
Figure 1. Dezadeash Lake (Titl'at Mān) and immediate watershed delineated in black. From Fradette, 2021.

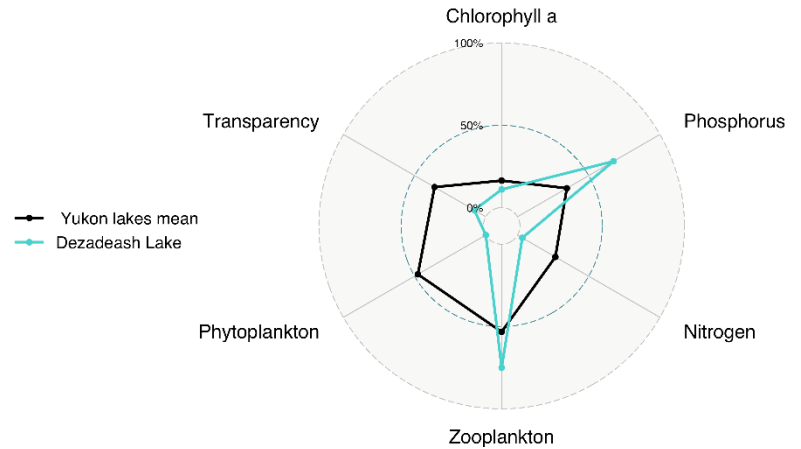
Figure 2. Relative values (rescaled from 0% to 100%) of water quality variables from the mean of all Yukon lakes that were sampled (shown in black) in comparison with Dezadeash Lake (shown in blue).

Total phosphorus (21.19 µg/L) and total nitrogen (0.05 mg/L) values in Dezadeash Lake were both slightly below the Yukon mean (Figure 2). Chlorophyll a (1.48 µg/L) was also below average. According to the Canadian water quality guidelines for the protection of aquatic life, Dezadeash Lake is meso-eutrophic.

Five zooplankton species were identified in Dezadeash Lake, which is above Yukon's average. However, seven phytoplankton species were identified, which is the lowest diversity of all Yukon lakes (Figure 2). Cyanobacteria concentration indicated a low risk exposure to cyanotoxins but one potential bloom former/toxin producer species of the cyanobacteria group was identified.

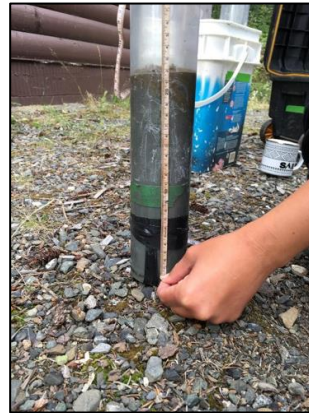
Figure 4. The longest sediment core retrieved from Dezadeash Lake.

Sediment cores were retrieved from Dezadeash Lake, but have not yet been analyzed for total metal, diatoms or zooplankton temporal changes. The longest core was 22 cm and was dated to 1973.

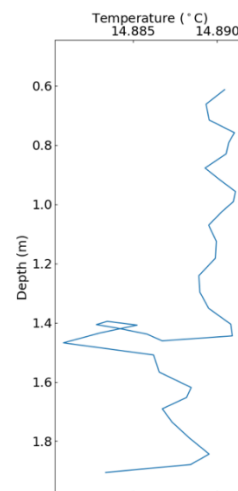
Figure 5. Temperature (°C) profile as measured in Dezadeash Lake. Figures from Fradette, 2021.

The temperature profile in Dezadeash Lake stops at 2m depth, so it is not possible to examine lake stratification. The surface temperature was 14.9°C on the day of sampling (Figure 5). Dissolved oxygen data was not available due to instrumentation malfunction.

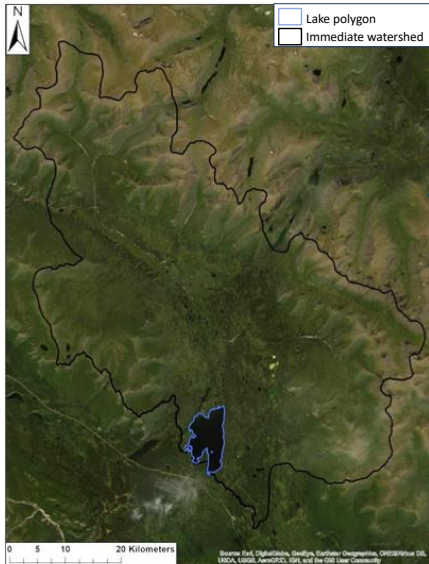
Figure 1. Kloo Lake and immediate watershed delineated in black. Adapted from Fradette, 2021.

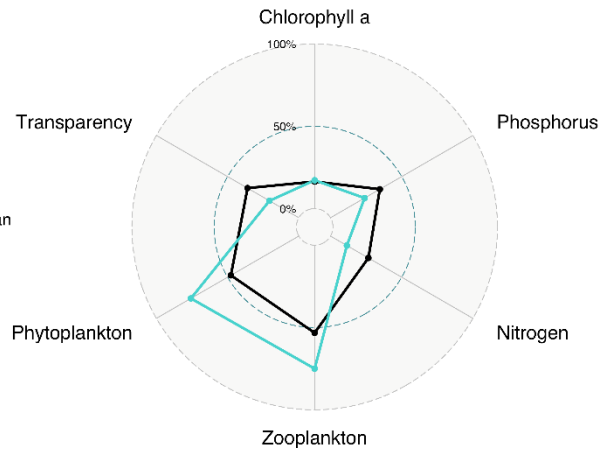
Figure 2. Relative values (rescaled from 0% to 100%) of water quality variables from the mean of all Yukon lakes that were sampled (shown in black) in comparison with Kloo Lake (shown in blue).

Total phosphorus (11.44 µg/L) and total nitrogen (0.12 mg/L) values in Kloo Lake were below the Yukon mean (Figure 2). Chlorophyll a (2.07 µg/L) was also below the Yukon average. According to the Canadian water quality guidelines for the protection of aquatic life, Kloo Lake is mesotrophic.

Five zooplankton species and 32 phytoplankton species were identified in Kloo Lake, which is above the average of sampled Yukon lakes (Figure 2). Cyanobacteria concentration indicated a low risk of cyanotoxin exposure. Two potential bloom formers / toxin producer species of the cyanobacteria group were identified.

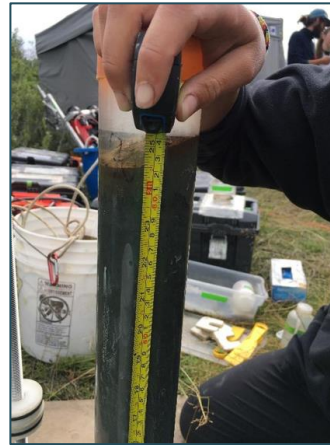
Figure 4. The longest sediment core from Kloo Lake.

Sediment cores were retrieved from Kloo Lake, but have not yet been analyzed for total metals, diatoms or zooplankton temporal changes. The longest core was 61 cm.

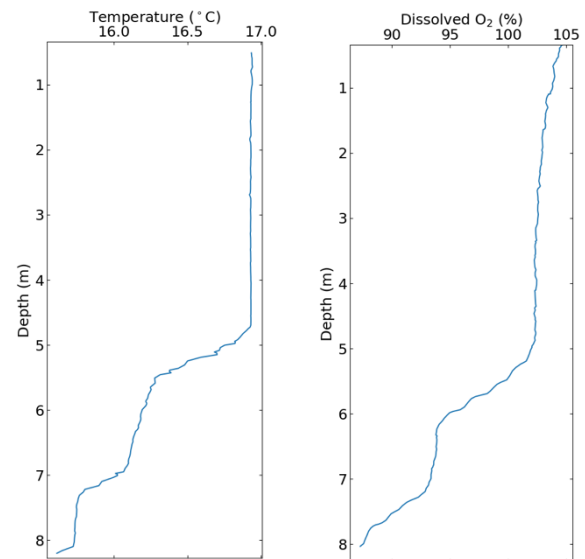
Figure 5. a) Temperature (°C) and b) Dissolved oxygen (%) as measured in Kloo Lake. Figures from Fradette, 2021.

The temperature profile shows a thermocline at 5.2 m and a hypolimnion at 5.4 m on the sampling day (Figure 5a). Dissolved oxygen was elevated throughout the profile, with minimal values around 90% of oxygen in the hypolimnion (Figure 5b).

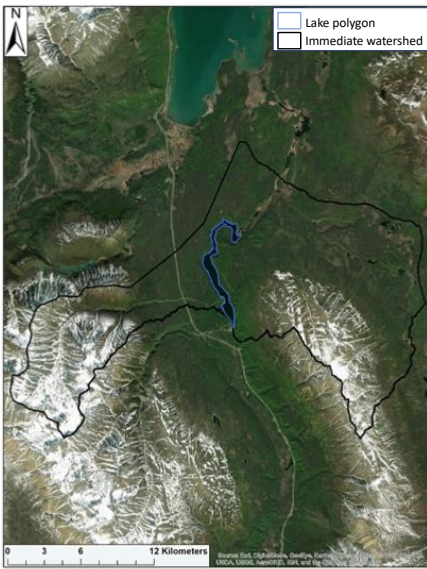
Figure 1. Klukshu Lake (Łu Gha Mǎn) and immediate watershed delineated in black. Adapted from Fradette, 2021.

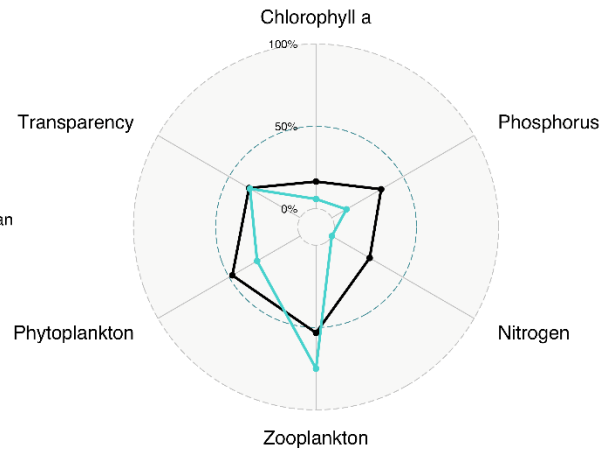
Figure 2. Relative values (rescaled from 0% to 100%) of water quality variables from the mean of all Yukon lakes that were sampled (shown in black) in comparison with Klukshu Lake (shown in blue).

Total phosphorus (8.37 µg/L) and total nitrogen (0.03 mg/L) values in Klukshu Lake were below the Yukon mean (Figure 2). Chlorophyll a (0.98 µg/L) was also below mean. According to the Canadian water quality guidelines for the protection of aquatic life, Klukshu Lake is oligotrophic.

Five zooplankton species were identified in Klukshu Lake, which is above the Yukon average. However, phytoplankton diversity was below the Yukon average, with 17 species identified (Figure 2). Cyanobacteria concentration indicated a low risk exposure to cyanotoxins and no potential bloom former / toxin producer species of the cyanobacteria group were identified.

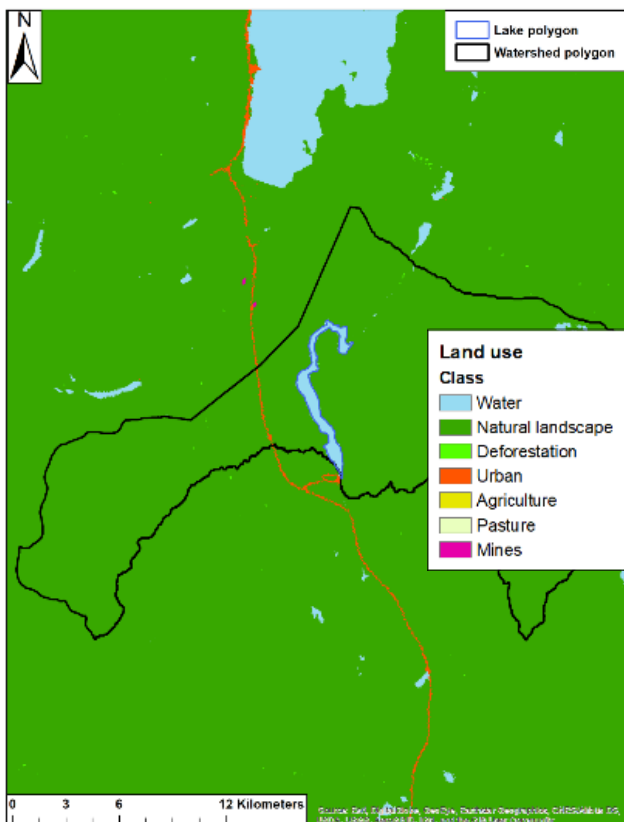
Figure 3. Immediate watershed and land use around Klukshu Lake. Figure from Fradette, 2021.

97.8% of Klukshu Lake's 79.88 km² watershed is natural. 2% is composed of water (including the lake itself). The remaining 0.2% of the watershed is comprised of urbanized land or forest losses (Figure 3).

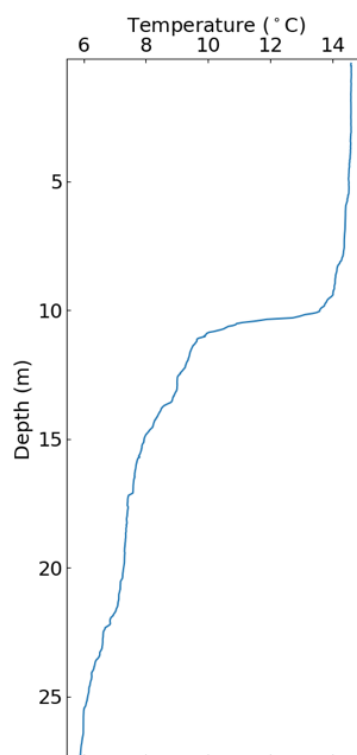
Figure 4. Temperature (°C) profile as measured in Klukshu Lake. Figures from Fradette, 2021.

The temperature profile shows a thermocline at 10.3m and a hypolimnion at 11.1m on the sampling day (Figure 3). The dissolved oxygen sensor was broken on the day of sampling and thus no oxygen data is available for this lake.

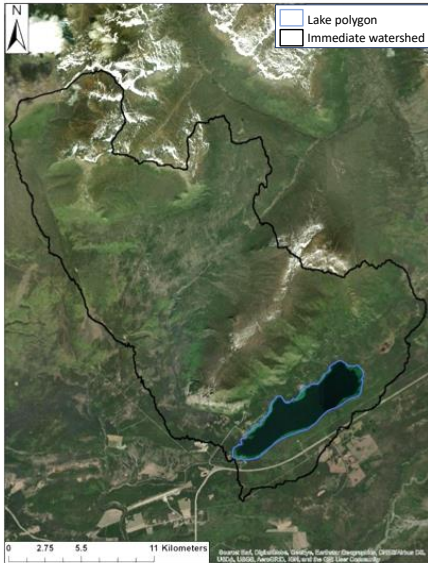
Figure 1. Pine Lake 2 and immediate watershed delineated in black. Adapted from Fradette, 2021.

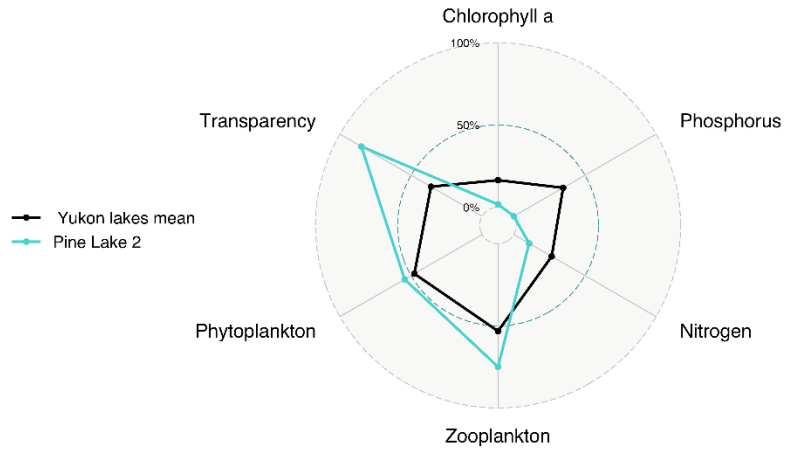
Figure 2. Relative values (rescaled from 0% to 100%) of water quality variables from the mean of all Yukon lakes that were sampled (shown in black) in comparison with Pine Lake 2 (shown in blue).

Total phosphorus (6.07 µg/L) and total nitrogen (0.11 mg/L) values in Pine Lake 2 were among the lowest observed across sampled Yukon lakes (Figure 2). Chlorophyll a (0.58 µg/L) was also below the Yukon average. According to the Canadian water quality guidelines for the protection of aquatic life, Pine Lake 2 is oligotrophic.

Five zooplankton species and 25 phytoplankton species were identified in Pine Lake 2, which is above the Yukon average (Figure 2). Cyanobacteria concentration indicated a low risk of exposure to cyanotoxins but one potential bloom former / toxin producer species of the cyanobacteria group was identified.

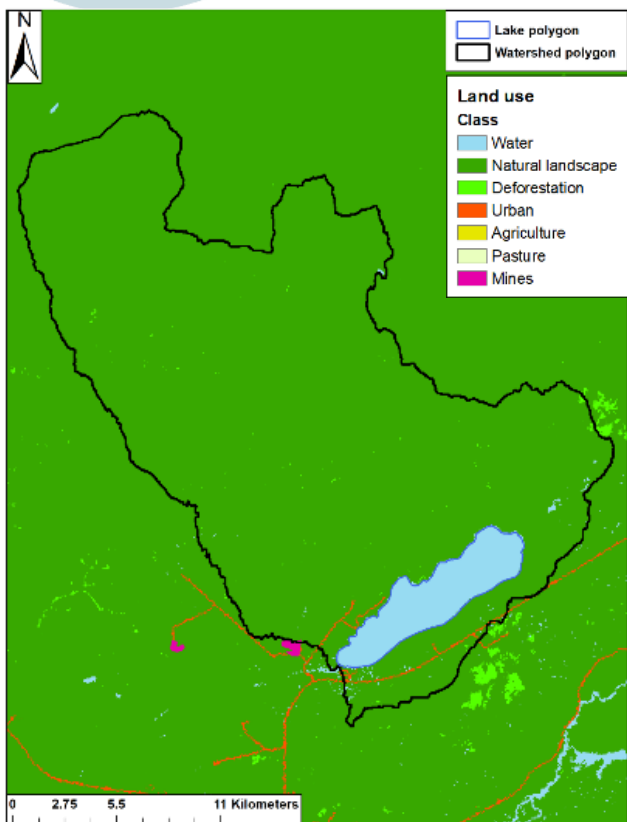
Figure 3. Immediate watershed and land use around Pine Lake 2. Figure from Fradette, 2021.

94.2% of Pine's Lake 2's 1061.53 km² watershed is natural. 5.4% is composed of water (including the lake itself). The remaining 0.4% of the watershed is comprised of urban, forest loss and mines (Figure 3).

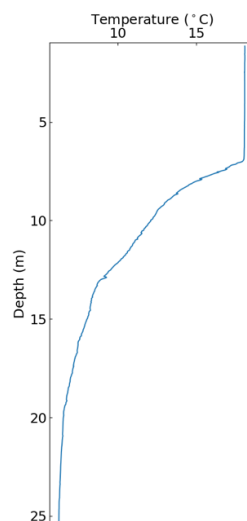
Figure 5. Temperature (°C) profile as measured in Pine Lake 2. Figures from Fradette, 2021

The temperature profile shows a thermocline at 7.5 m, and a hypolimnion at 13.1 m on the sampling day (Figure 5). Dissolved oxygen data was not available for this lake.
