**Re: Yukon Emergency Flood Protection Works – Status Update**

## 1.0 CURRENT STATUS

## 1.1 Existing Infrastructure

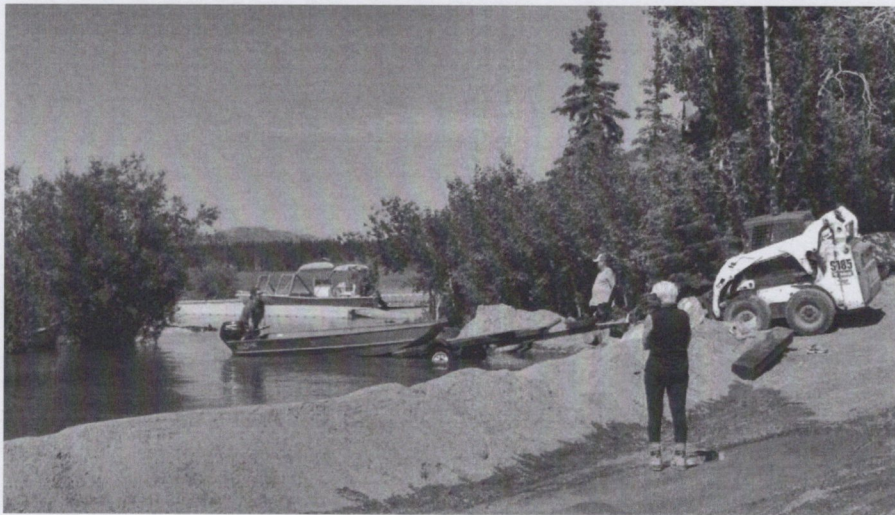
Early earth dikes of sand and gravel were first pushed into place in late June, as a first response, and prior to KGS Group's arrival, as per Photo 1 below. The dikes were intended as this first response to secure sites until more resources were available (sand bags and superbags were limited initially) and awaiting arrival of the engineering emergency response team of KGS Group, Manitoba Infrastructure, and Canadian Armed Forces (CAF).

Photo 1. Early Earth Dike of Sand and Gravel.

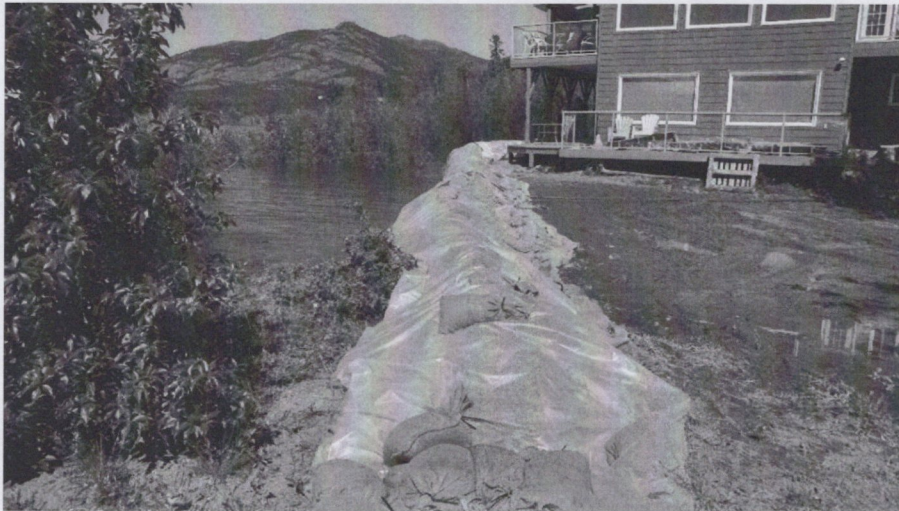
Many of the early earth dikes were wrapped with poly wrap as per Photo 2 below.

Photo 2. Typical Sand and Gravel Dike, Wrapped in Poly.

Properties with super bag dike structures or sandbag dike structures, constructed by CAF, have been the most stable and secure flood protection works to date. Sand and gravel dikes or poly-wrapped sand dikes were particularly susceptible to shoreline washout during wave action and wind. Almost all of them were replaced with the more secure diking systems once the CAF support became available in July.

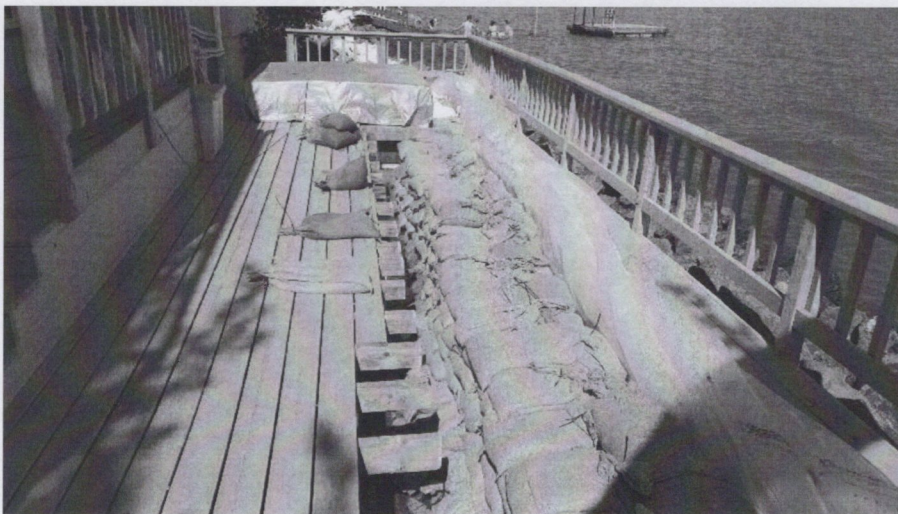
Sandbag dikes were used frequently, constructed both by homeowners and later by the army. Photo 3 is typical of a dike in early July. That dike was later raised another 1 metre and all of the deck was removed. Photo 4 is another example of an early sandbag dike. Note in that photo the murky, sandy coloured water, indicative of ongoing shoreline erosion. Shoreline erosion and undermining was a common threat in numerous areas.

Photo 3. Typical Sandbag dike

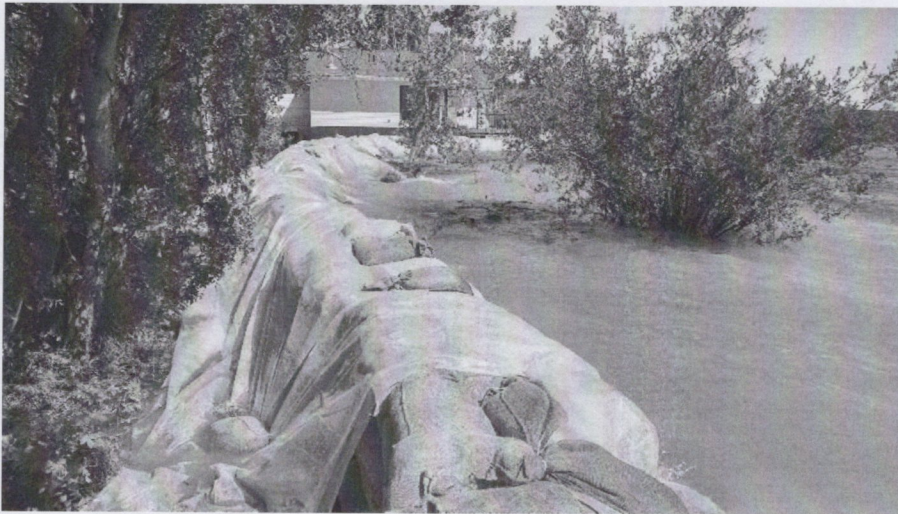
Photo 4. Typical Sandbag Dike

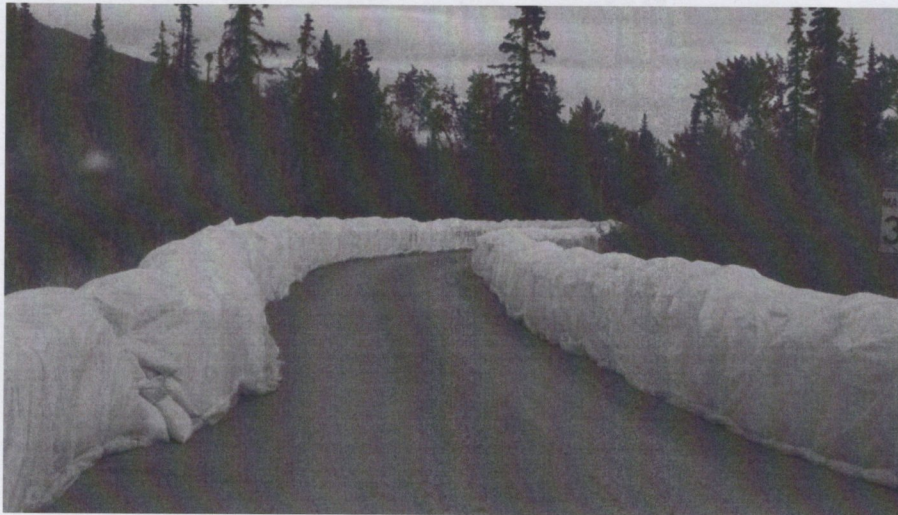
Photo 5. Superbag Dikes along South M'clintock Road.

Super bag dikes, as per Photo 5 and Photo 6, were used in areas where equipment access was readily available, both to protect critical access roads (Photo 5) as well as homes (Photo 6).

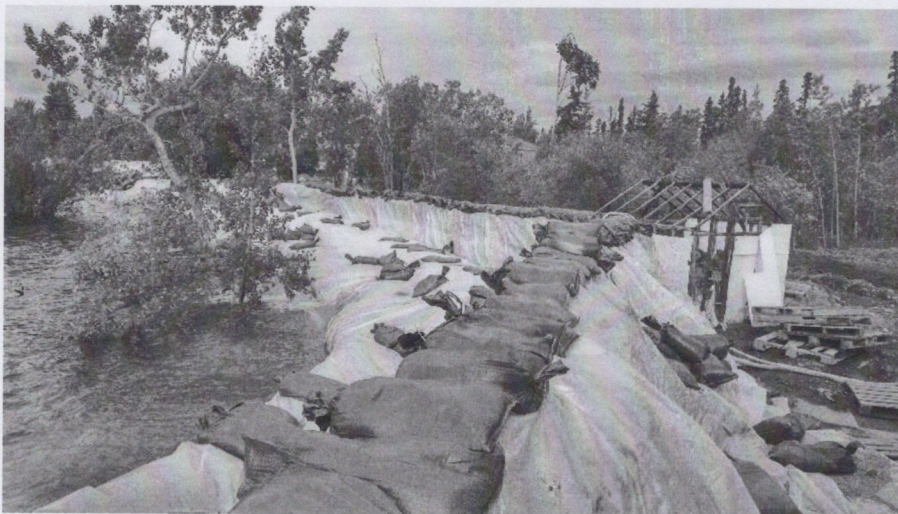
Many of the early dikes were particularly susceptible to undermining of foundations and internal erosion of the dike (sand and gravel). A plume of silt along the shoreline meant, for example, that the fines were being washed out of the sand and gravel dikes. If left unchecked, dike failure would be the consequence.

This concern resulted in a second line of dikes being constructed in numerous locations along Army Beach, South M'clintock, and Bayview Road, now set back further from the shoreline, once the Canadian Armed Forces had arrived. Photo 7 shows such a typical reconstruction. The concern was that if any one dike failed then an entire community might be inundated.

Photo 7. Second Line of Sandbag Dikes Constructed Behind Original Dike Line

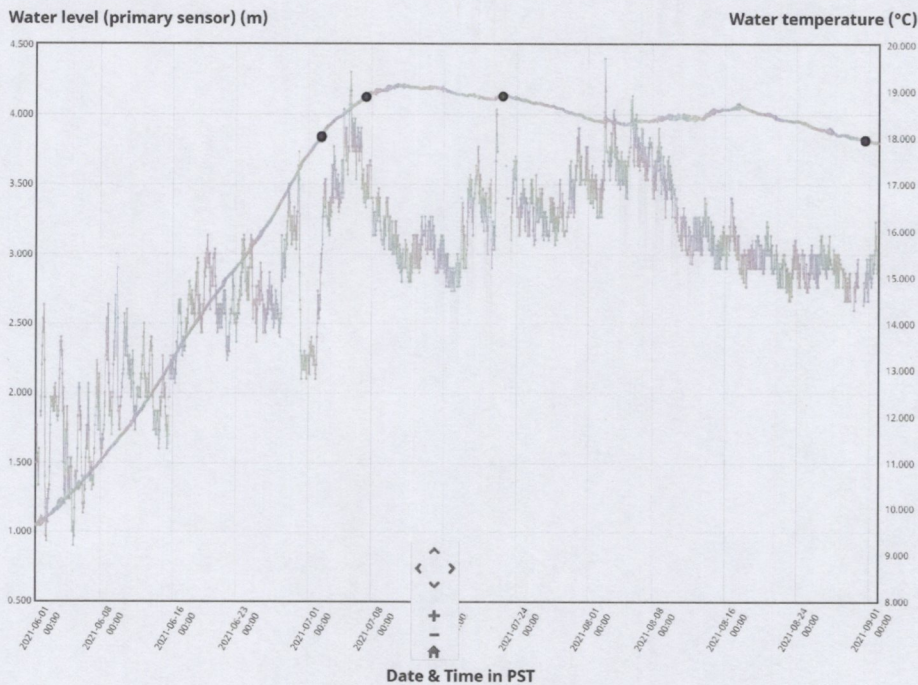
**FIGURE 1. GOVERNMENT OF CANADA HYDROMETRIC GAUGING DATA, MARSH LAKE GAUGE**

Figure 1 shows the Marsh Lake Gauging Station hydrograph from the beginning of the flood event to September 1, 2021. On September 1, 2021, Marsh Lake gauging station was reading 3.81 m, local datum, which in Canadian Geodetic Vertical Datum 2013 is Elevation 657.48 m. All surveying during this event has been to the 2013 reference datum. Confusion can occur because prior to 2013, including the LiDAR survey, all levels were referenced to a Canadian Geodetic Survey of Canada Datum which is listed as 0.315 m lower than the later 2013 datum.

Regardless of the datum, lake levels had dropped approximately 0.4 m by September 1 versus the early July peak. Latest lake level projections, as provided by email (Anthony Bier to [cffc@yukon.ca](mailto:cffc@yukon.ca) and Holly Goulding, August 27, 2021) are that “YEC has high confidence that freeze-up will occur below Full Supply Level of 656.23 (>1 m below current levels)”. We understand that to mean that lake levels are anticipated to drop a further metre from current levels before freeze-up. That prediction would be consistent with the lake drawdown rate shown in the last two weeks on Figure 1. If so, that places the lake level at approximately 1.4 m lower than its early July peak.
