## **Yukon River Watershed - Lakes**

## Lake 13-587

# Bennett Lake

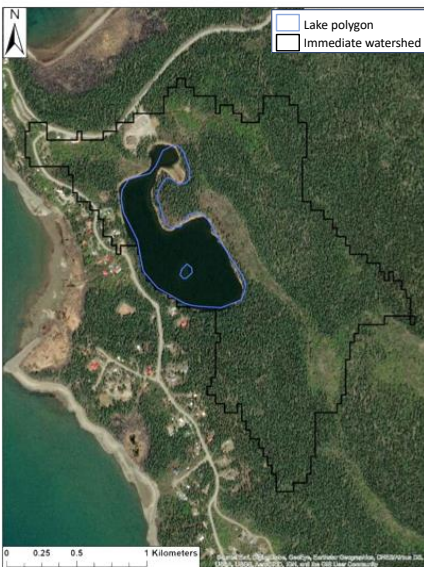
Figure 1. Lake 13-587 and immediate watershed delineated in black. Adapted from Fradette, 2021.

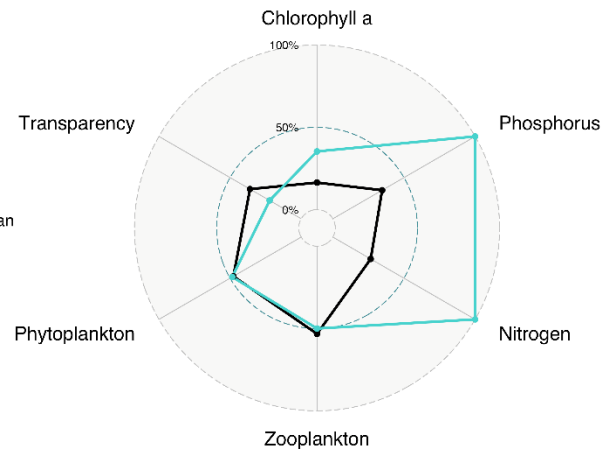
Figure 2. Relative values (rescaled from 0% to 100%) of water quality variables from the mean of all Yukon lakes that were sampled (black) in comparison with Lake 13-587 (blue).

Total phosphorus (28.50 µg/L) and total nitrogen (0.84 mg/L) values in Lake 13-587 were above the Yukon average, while chlorophyll a (3.81 µg/L) was below the Yukon average (Figure 2). According to the Canadian water quality guidelines for the protection of aquatic life, Lake 13-587 is meso-eutrotrophic.

Four zooplankton species and 23 phytoplankton species were identified in Lake 13-587, which is the same as the Yukon average (Figure 2). Cyanobacteria concentration indicated a low risk of cyanotoxin exposure. One potential bloom formers / toxin producer species of the cyanobacteria group was identified.

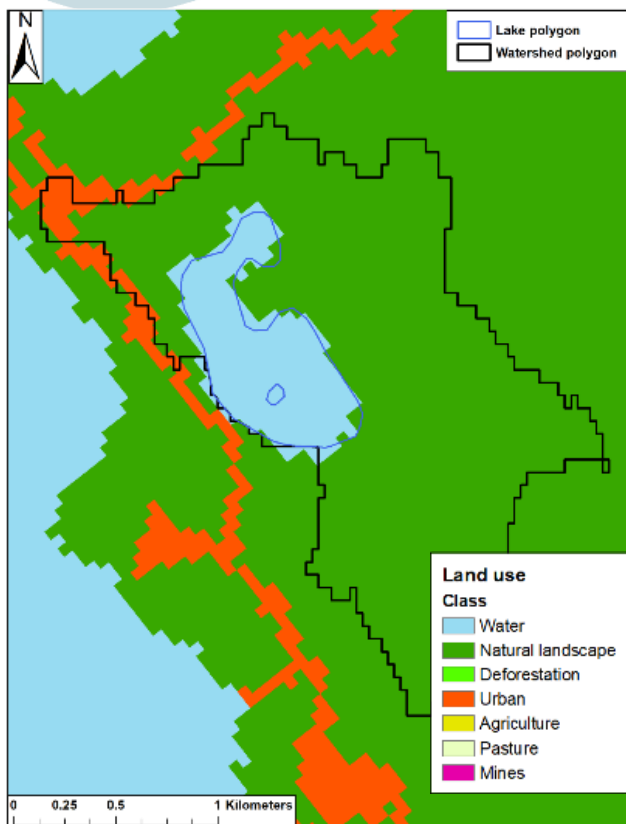
81.83% of Lake 13-587's 0.77 km<sup>2</sup> watershed is natural. 15.04% is composed of water (including the lake itself). The remaining 3.13% of the watershed is urbanized land (Figure 3).

Figure 3. Immediate watershed and land use around Lake 13-587. Figure from Fradette, 2021.

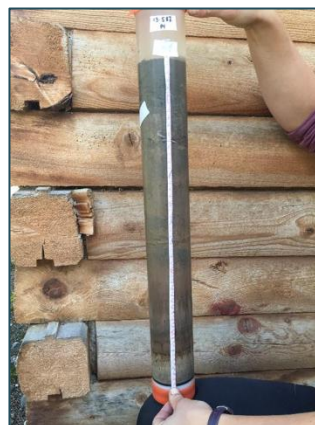
Sediment cores were retrieved from Lake 13-587, but have not yet been analyzed for total metals, diatoms or zooplankton cladoceran temporal changes. The longest core was 48 cm.

Figure 4. The longest sediment core retrieved from Lake 13-587.

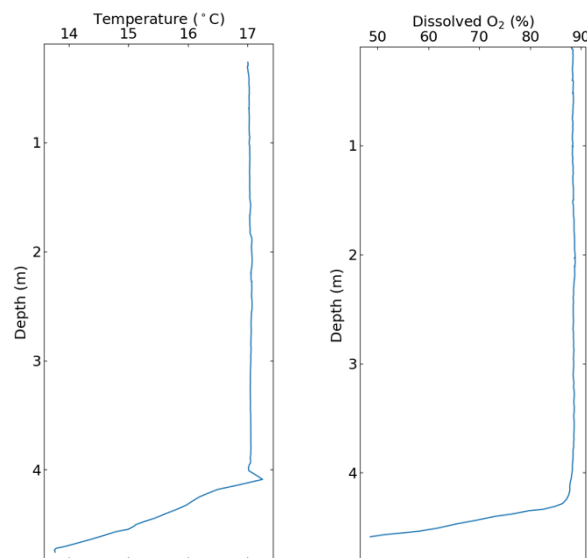
The temperature profile shows a thermocline at 4.6 m and a hypolimnion at 4.8 m on the sampling day (Figure 5a). Dissolved oxygen was elevated throughout the profile, but reduced to 50% of oxygen in the hypolimnion (Figure 5b).

Figure 5. a) Temperature (°C) and b) Dissolved oxygen (%) as measured in Lake 13-587. Figures from Fradette, 2021.

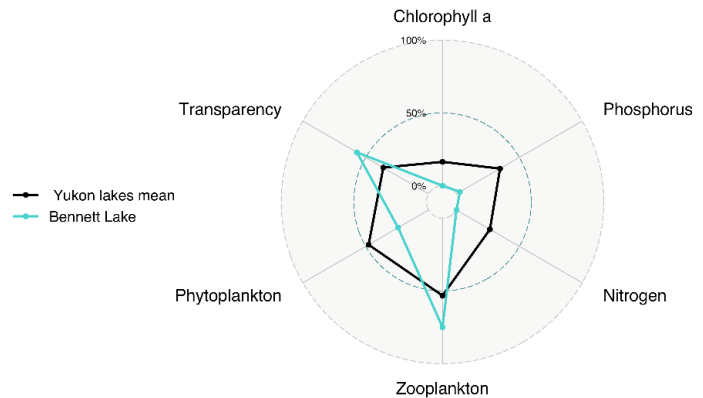
Figure 2. Relative values (rescaled from 0% to 100%) of water quality variables from the mean of all Yukon lakes that were sampled (shown in black) in comparison with Bennett Lake (shown in blue).

Total phosphorus (6.68 µg/L) and total nitrogen (0.03 mg/L) concentrations in Bennett Lake were low compared to the Yukon mean (Figure 2). Chlorophyll a (0.42 µg/L) was also below the mean. According to the Canadian water quality guidelines for the protection of aquatic life, Bennett Lake is oligotrophic.

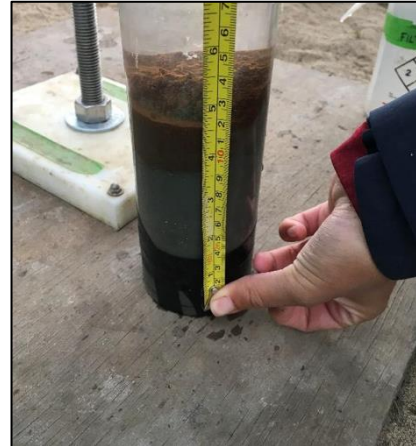
Sediment cores were retrieved from Bennett Lake, but core length was not long enough for analysis.

Figure 4. The longest sediment core retrieved from Bennett Lake was 11cm long.

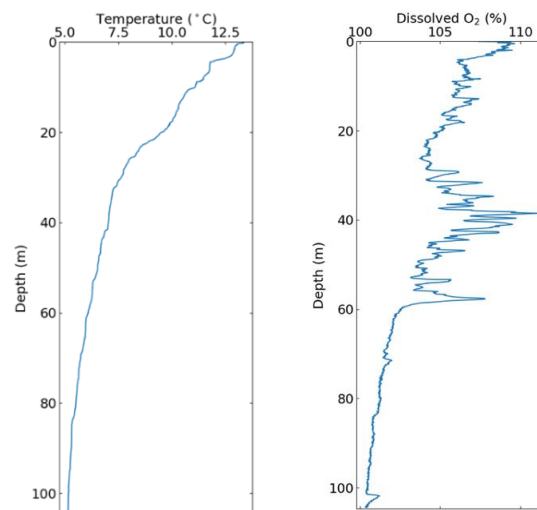
The temperature profile shows a thermocline at 0.3 m and a hypolimnion at 8.8 m to 25m on the sampling day (Figure 4a). Dissolved oxygen remained elevated throughout the profile, with the lowest values of 100% saturation found at lake bottom (Figure 4b).

Figure 5. a) Temperature (°C) and b) Dissolved oxygen (%) as measured in Bennett Lake. Figure from Fradette, 2021.

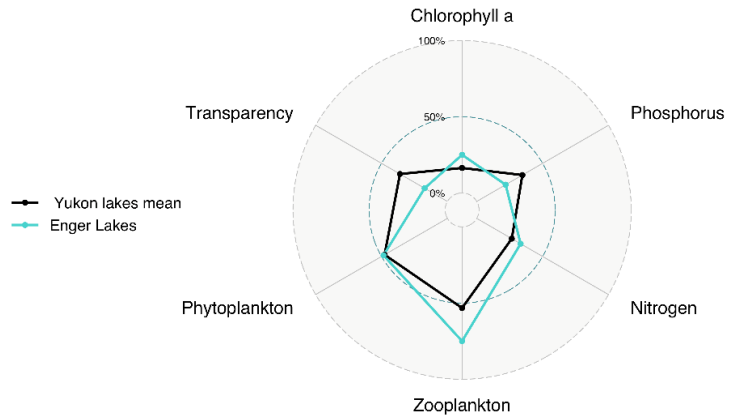
Figure 2. Relative values (rescaled from 0% to 100%) of water quality variables from the mean of all Yukon lakes that were sampled (black) in comparison with Enger Lake (blue).

Total phosphorus (10.99 µg/L) and total nitrogen (0.30 mg/L) values in Enger Lake were slightly below the Yukon mean (Figure 2). Chlorophyll a (2.82 µg/L) was also below average. According to the Canadian water quality guidelines for the protection of aquatic life, Enger Lake is mesotrophic.

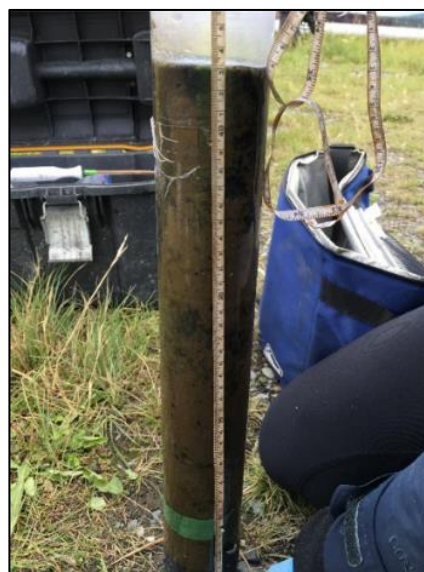
Sediment cores were retrieved from Enger Lake, but have not yet been analyzed for total metal, diatoms or zooplankton cladoceran temporal changes. The longest core was 56 cm. A black layer was observed on top of the core that might have been caused by forest fire that occurred 2-3 weeks prior to sampling.

Figure 4. The second-longest sediment core retrieved from Enger Lake was 43 cm. Picture from the longest core was lost.

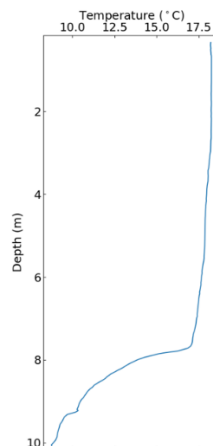
The temperature profile shows a thermocline at 7.8m and a hypolimnion at 9.5m on the sampling day (Figure 5). Dissolved oxygen data was unavailable due to instrumentation malfunction.

Figure 5. Temperature (°C) profile as measured in Enger Lake. Figures from Fradette, 2021.

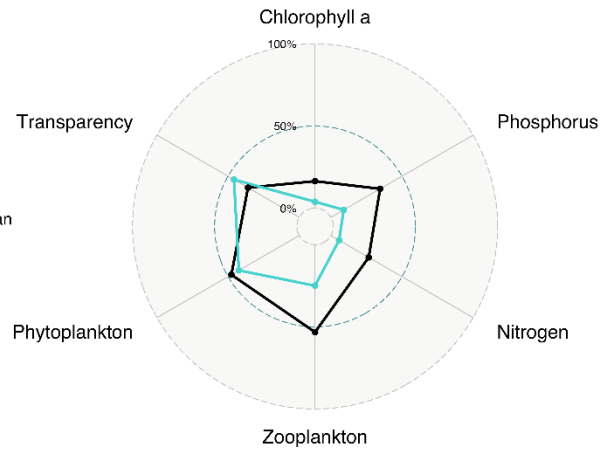
Figure 2. Relative values (rescaled from 0% to 100%) of water quality variables from the mean of all Yukon lakes that were sampled (shown in black) in comparison with Ethel Lake (shown in blue).

Total phosphorus (8.10 µg/L) and total nitrogen (0.07 mg/L) values in Ethel Lake were both lower than the Yukon mean (Figure 2). Chlorophyll a (0.80 µg/L) was also below average. According to the Canadian water quality guidelines for the protection of aquatic life, Ethel Lake is oligotrophic.

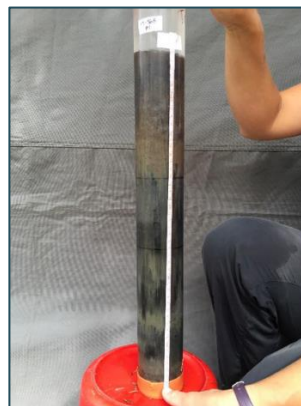
Sediment cores were retrieved from Ethel Lake, but have not yet been analyzed for total metals, diatoms or zooplankton cladoceran temporal changes yet. The longest core was 46 cm.

Figure 4. The longest sediment core from Ethel Lake.

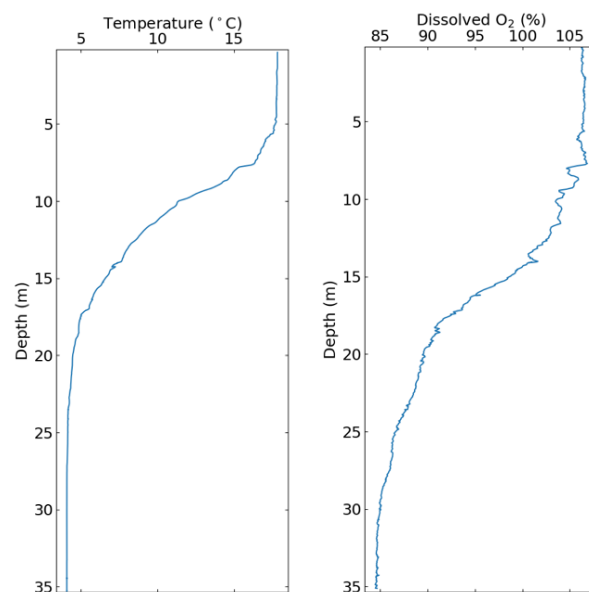
The temperature profile shows a thermocline at 7.7 m and a hypolimnion at 14.1 m on the day of sampling (Figure 5a). Dissolved oxygen had a value of 106% at the surface and reduced to 85% in the hypolimnion (Figure 5b).

Figure 5. a) Temperature (°C) and b) Dissolved oxygen (%) as measured in Ethel Lake. Figures from Fradette, 2021.

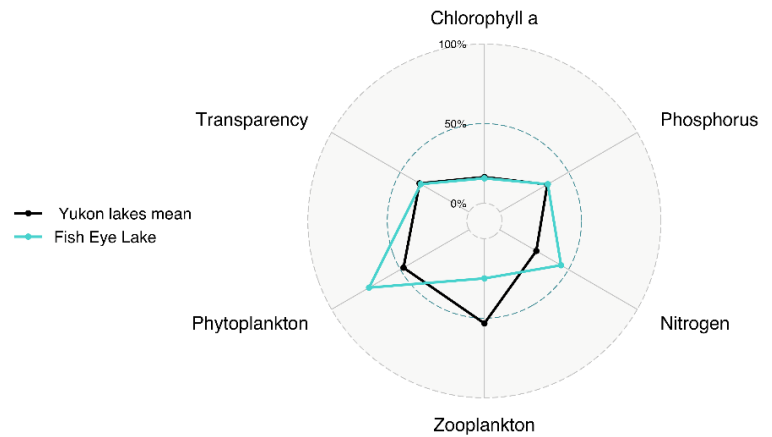
Figure 1. Relative values (rescaled from 0% to 100%) of water quality variables from the mean of all Yukon lakes that were sampled (shown in black) in comparison with Fish Eye Lake (shown in blue).

Total phosphorus (13.92 µg/L) and total nitrogen (0.39 mg/L) values in Fish Eye Lake were similar to the Yukon mean. Chlorophyll a (1.92 µg/L) was slightly below the mean (Figure 2). According to the Canadian water quality guidelines for the protection of aquatic life, Fish Eye Lake is mesotrophic.

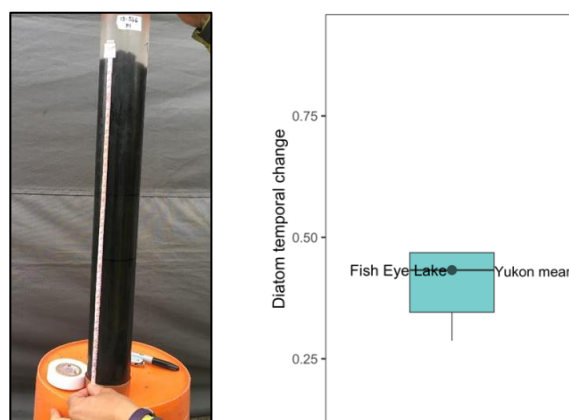
The longest core retrieved from Fish Eye Lake was 49 cm long. The bottom of the core was dated to 1864 (Figure 4a). The analysis of diatom assemblage from top and bottom of the core revealed a temporal dissimilarity of 0.43 (Figure 4b).

Figure 4. a) The longest sediment core retrieved from Fish Eye Lake. b) Mean ( $\pm$  Standard error) of diatom temporal change between the bottom and the top of the core. Fish Eye Lake value is indicated with a green point.

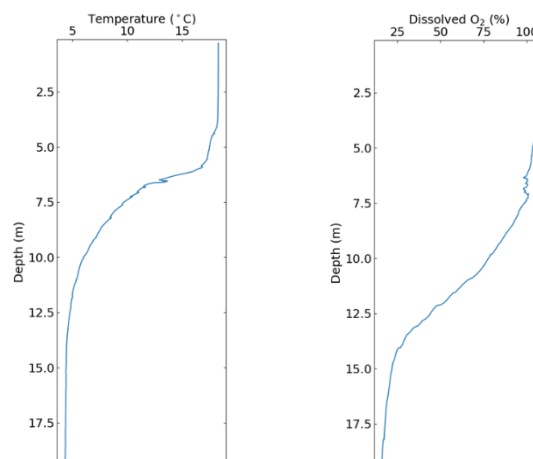
The temperature profile shows a thermocline at 6.6 m and a hypolimnion at 8.5 m on the sampling day (Figure 5a). Dissolved oxygen had a value of 105% at the surface of the lake, but reduced to 16.7% of oxygen in the hypolimnion (Figure 5b).

Figure 5. a) Temperature ( $^{\circ}$ C) and Dissolved oxygen (%) as measured in Fish Eye Lake. Figures from Fradette, 2021.

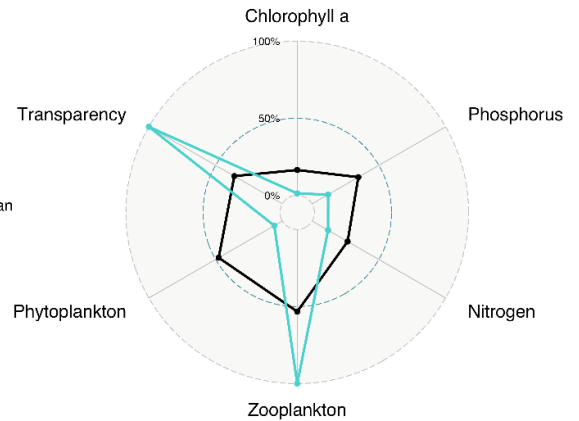
Figure 2. Relative values (rescaled from 0% to 100%) of water quality variables from the mean of all Yukon lakes that were sampled (shown in black) in comparison with Fox Lake (shown in blue).

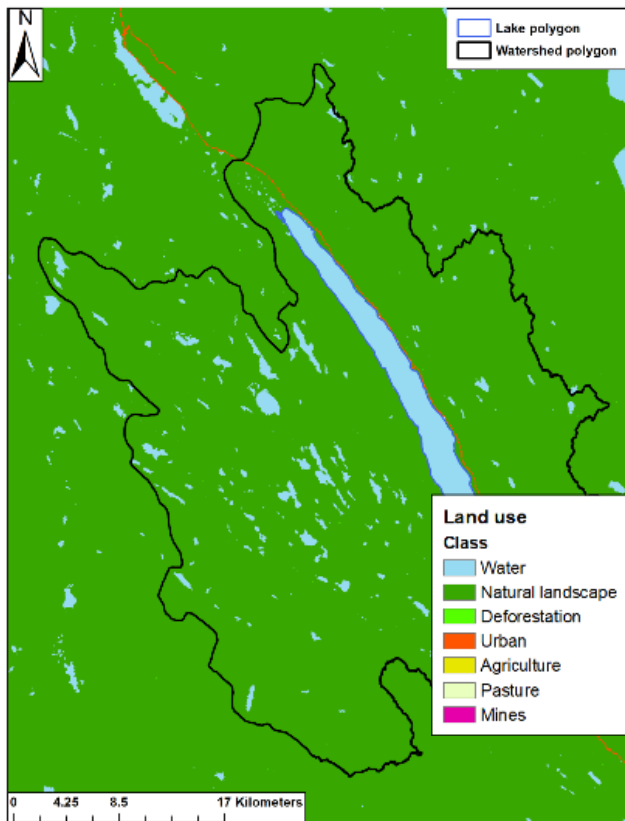
91.5% of Fox Lake's 282.79 km<sup>2</sup> watershed is natural. 8.2% is composed of water (including the lake itself). The remaining 0.3% of the watershed is comprised of forest loss or urbanized land (Figure 3).

Figure 3. Immediate watershed and land use around Fox Lake. Figure from Fradette, 2021.

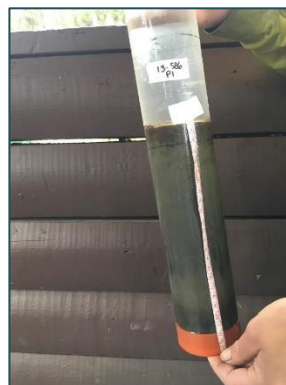
Sediment cores were retrieved from Fox Lake, but have not yet been analyzed for total metals, diatoms or zooplankton cladoceran temporal changes. The longest core was 22 cm.

Figure 4. The longest sediment core from Fox Lake.

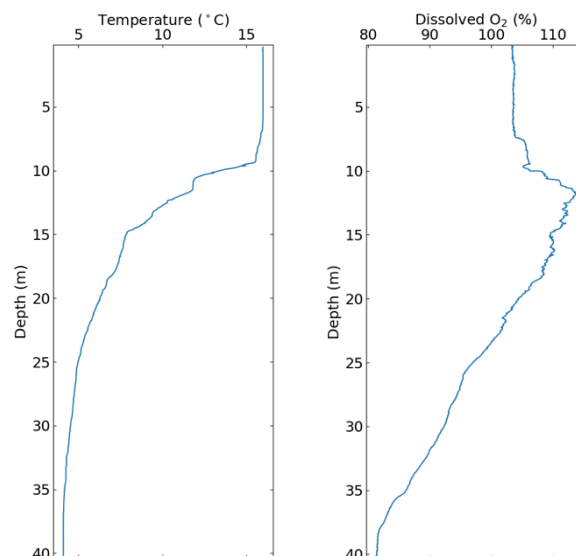
The temperature profile shows a thermocline at 9.8m and a hypolimnion at 14.7m on the sampling day (Figure 5a). Dissolved oxygen was elevated throughout the profile, with minimal values around 83% of oxygen in the hypolimnion (Figure 5b).

Figure 5. a) Temperature (°C) and b) Dissolved oxygen (%) as measured in Fox Lake. Figures from Fradette, 2021.

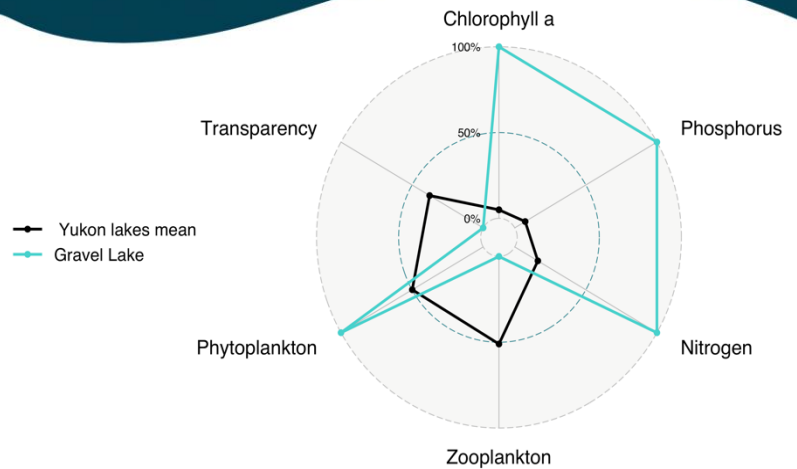
Figure 2. Relative values (rescaled from 0% to 100%) of water quality variables from the mean of all Yukon lakes sampled (black) in comparison with Gravel Lake (blue).

Total phosphorus (240.10 µg/L) and total nitrogen (1.80 mg/L) values in Gravel Lake were the highest values observed in sampled Yukon Lakes (Figure 2). Chlorophyll a (189.49 µg/L) was also the highest value observed across Yukon lakes. According to the Canadian water quality guidelines for the protection of aquatic life, Gravel Lake is hyper-eutrophic. These high values might be partially explained by the very shallow depth and small size of the lake and the proximity of the Highway.

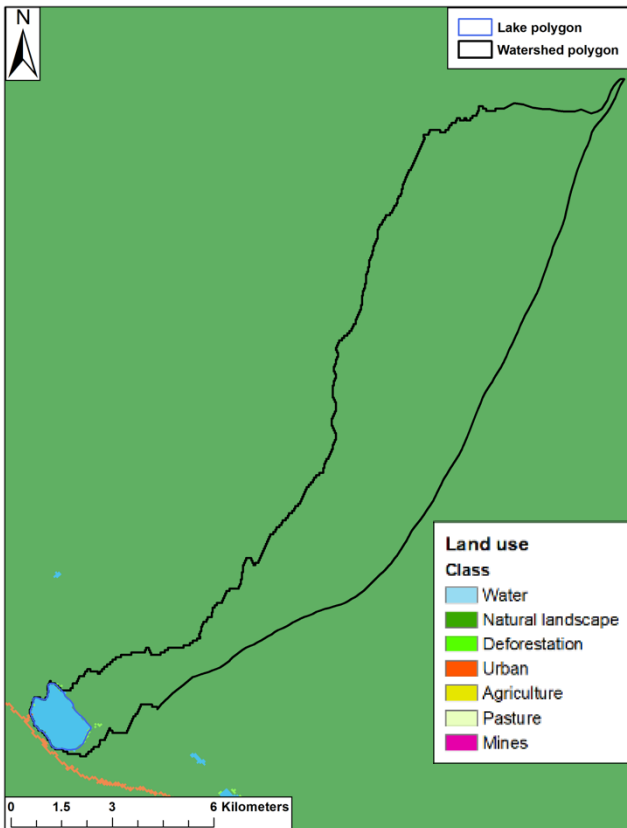
97.3% of Gravel Lake (pond)'s 14.61 km<sup>2</sup> watershed is natural. 2.6% is composed of water (including the lake itself). The remaining 0.1% of the watershed comprised of 0.08% of forest loss and <0.01% of urbanization (Figure 3).

Figure 3. Watershed and land use around Gravel Lake (pond). Figure from Fradette, 2021.

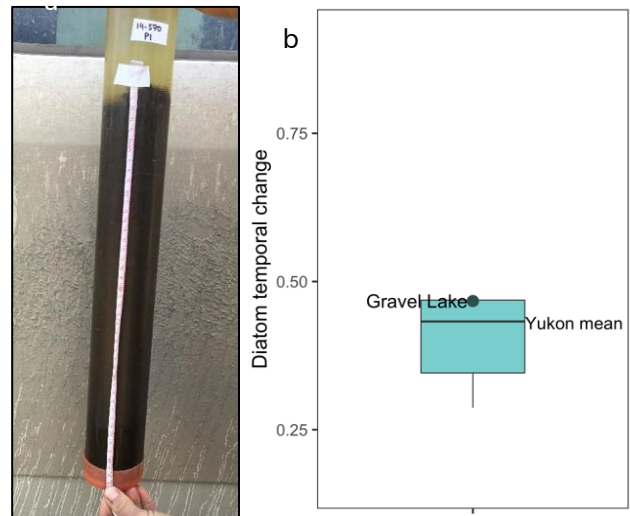
Figure 4. a) The longest sediment core retrieved from Gravel Lake. b) Mean ( $\pm$  Standard error) of diatom temporal change between the bottom and the top of the core. Gravel Lake (pond) value is indicated with a green point.

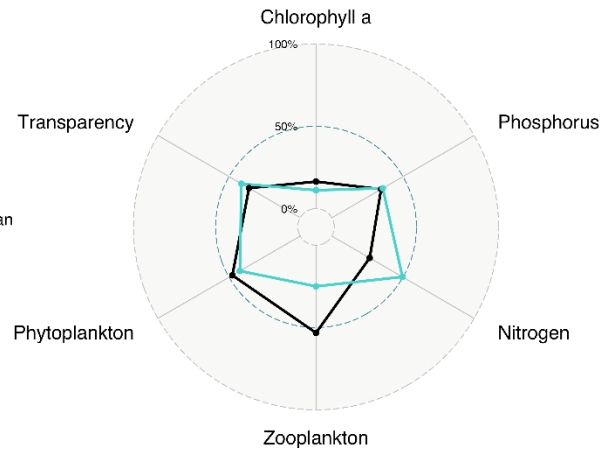
Figure 2. Relative values (rescaled from 0% to 100%) of water quality variables from the mean of all Yukon lakes that were sampled (shown in black) in comparison with Jackfish Lake (shown in blue).

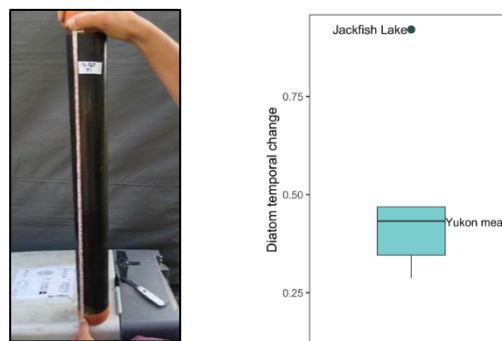
Figure 4. a) The longest sediment core retrieved from Jackfish Lake. b) Mean ( $\pm$  Standard error) of diatom temporal change between the bottom and the top of the core. Jackfish Lake value is indicated with a green point.

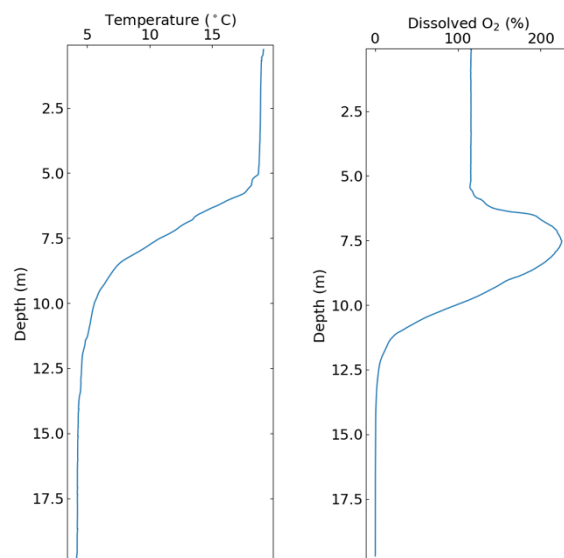
Figure 4. a) Temperature ( $^{\circ}$ C) and b) Dissolved oxygen (%) as measured in Jackfish Lake. Figures from Fradette, 2021.

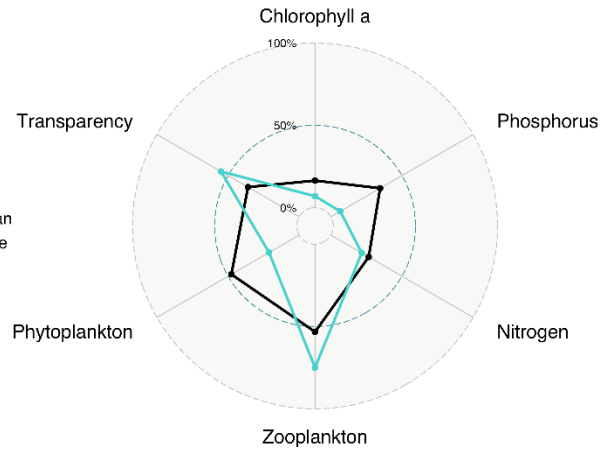
Figure 2. Relative values (rescaled from 0% to 100%) of water quality variables from the mean of all Yukon lakes that were sampled (shown in black) in comparison with Little Salmon Lake (shown in blue).

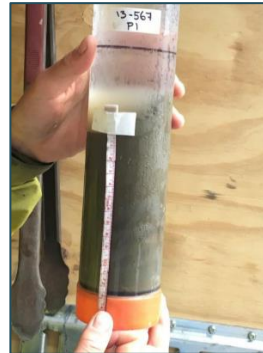
Sediment cores were retrieved from Little Salmon Lake, but were not analyzed due to their short length.

Figure 4. The longest sediment core retrieved from Little Salmon Lake was 12 cm long.

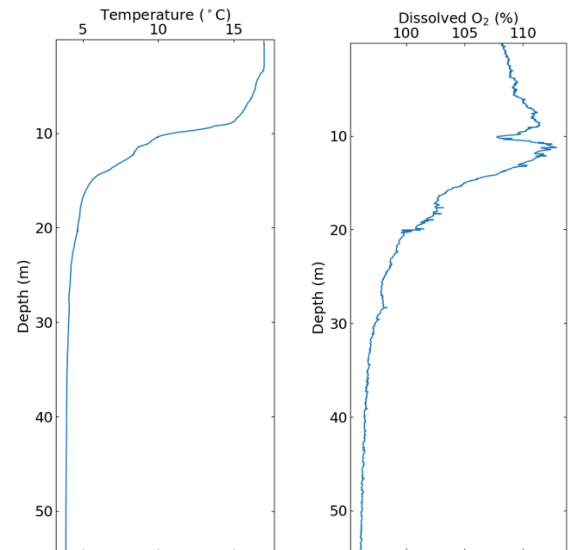
Figure 5. a) Temperature (°C) and b) Dissolved oxygen (%) as measured in Little Salmon Lake. Figures from Fradette, 2021.

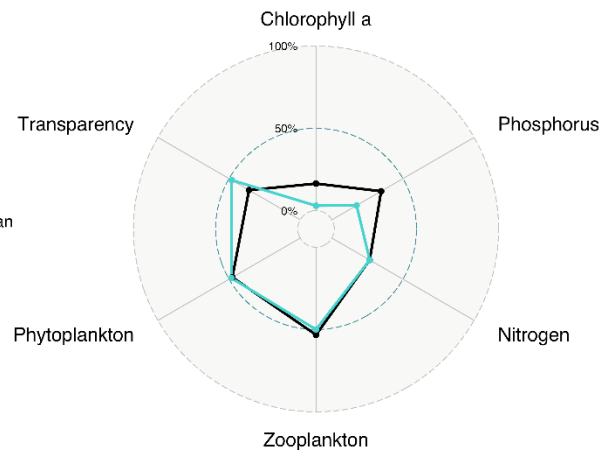
Figure 2. Relative values (rescaled from 0% to 100%) of water quality variables from the mean of all Yukon lakes that were sampled (shown in black) in comparison with Minto Lake (shown in blue).

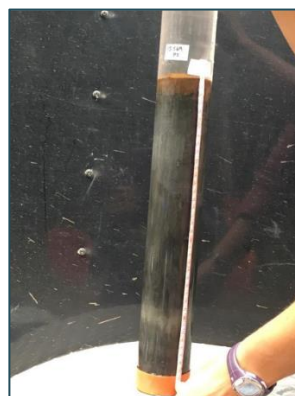
Figure 4. The second-longest sediment core from Minto Lake was 37.5 cm. The longest core picture was lost.

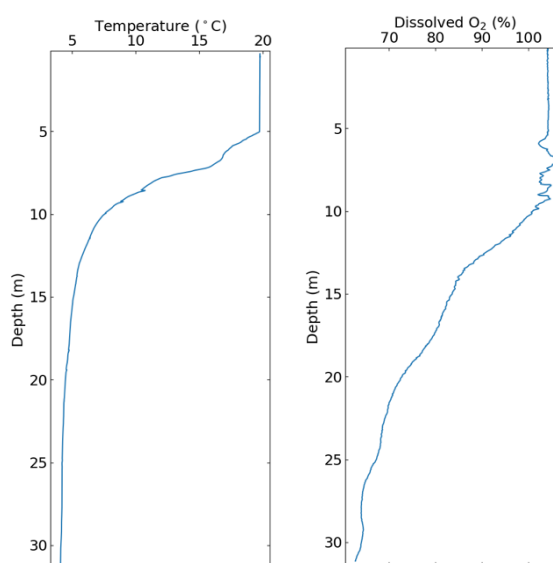
Figure 5. a) Temperature (°C) and b) Dissolved oxygen (%) as measured in Minto Lake. Figures from Fradette, 2021.
