Tséi Zhéte Sinwaa Éex'i Yé Conrad Historic Site

MANAGEMENT PLAN

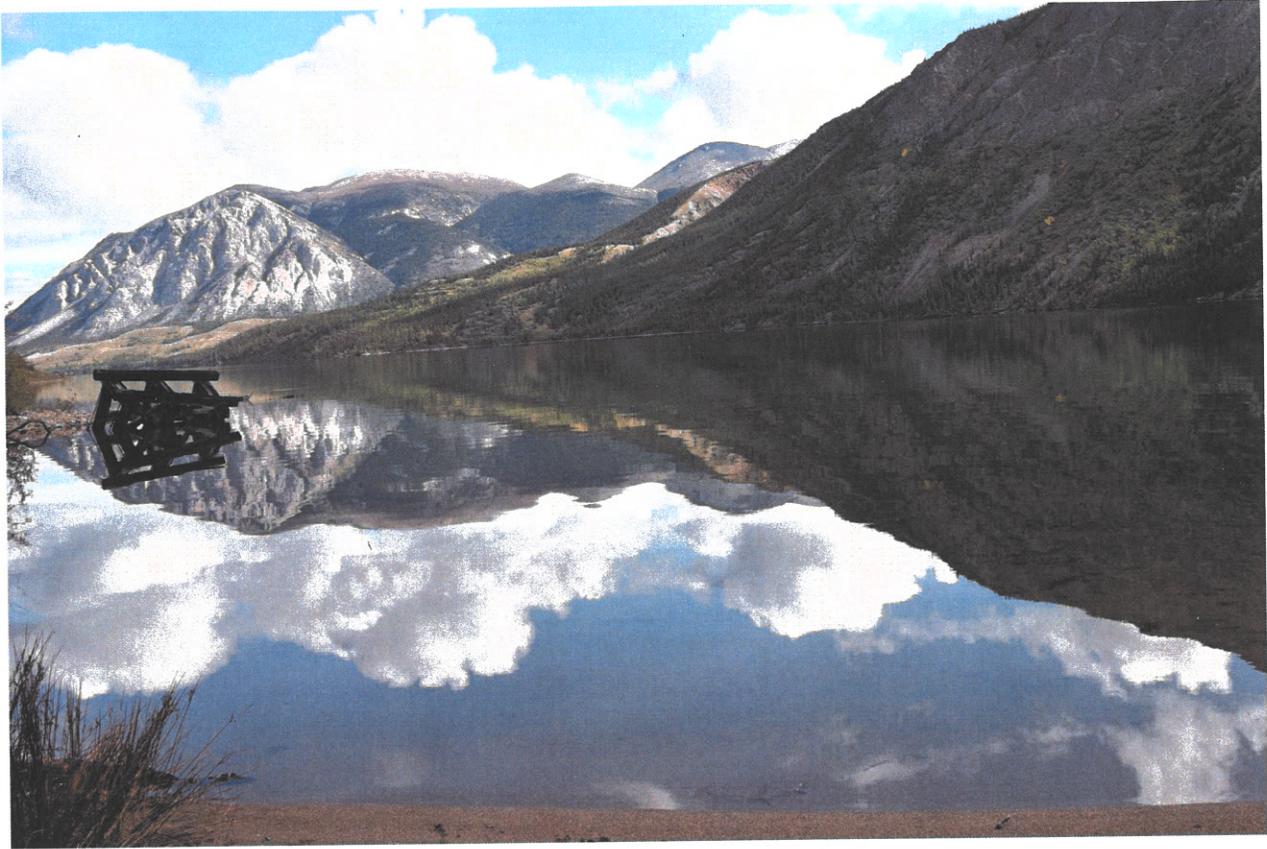
Tséi Zhéte / Sinwaa Éex'i Yé / Conrad Historic Site Management Plan

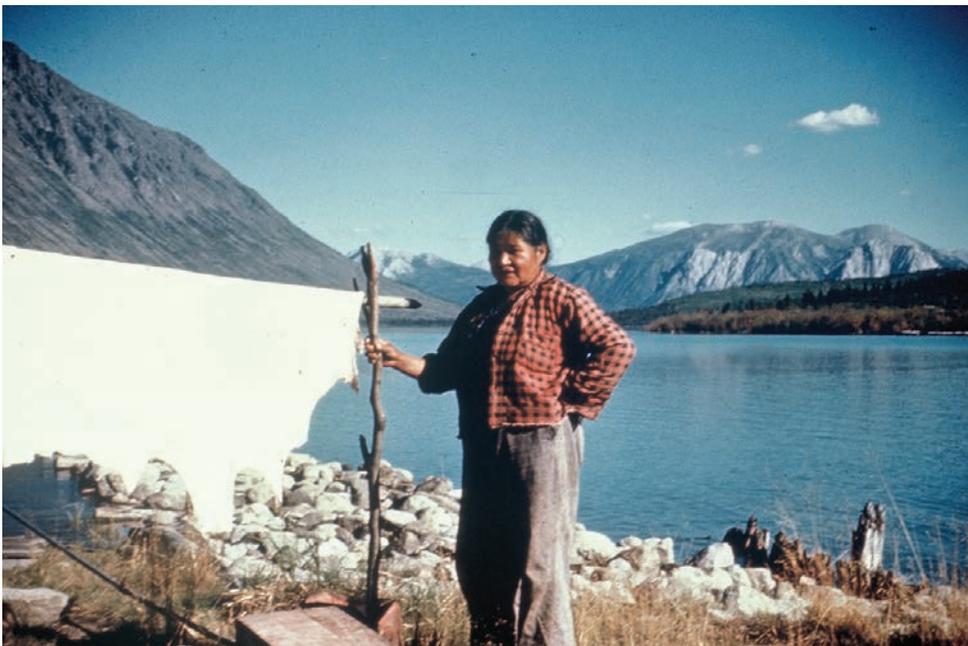
Angela Sidney/Ch'ünèhtè' Mā/Stúw with washed moosehide, August 1949, Carcross; Howling Rock is in the background at right. Canadian Museum of Civilization S71-645

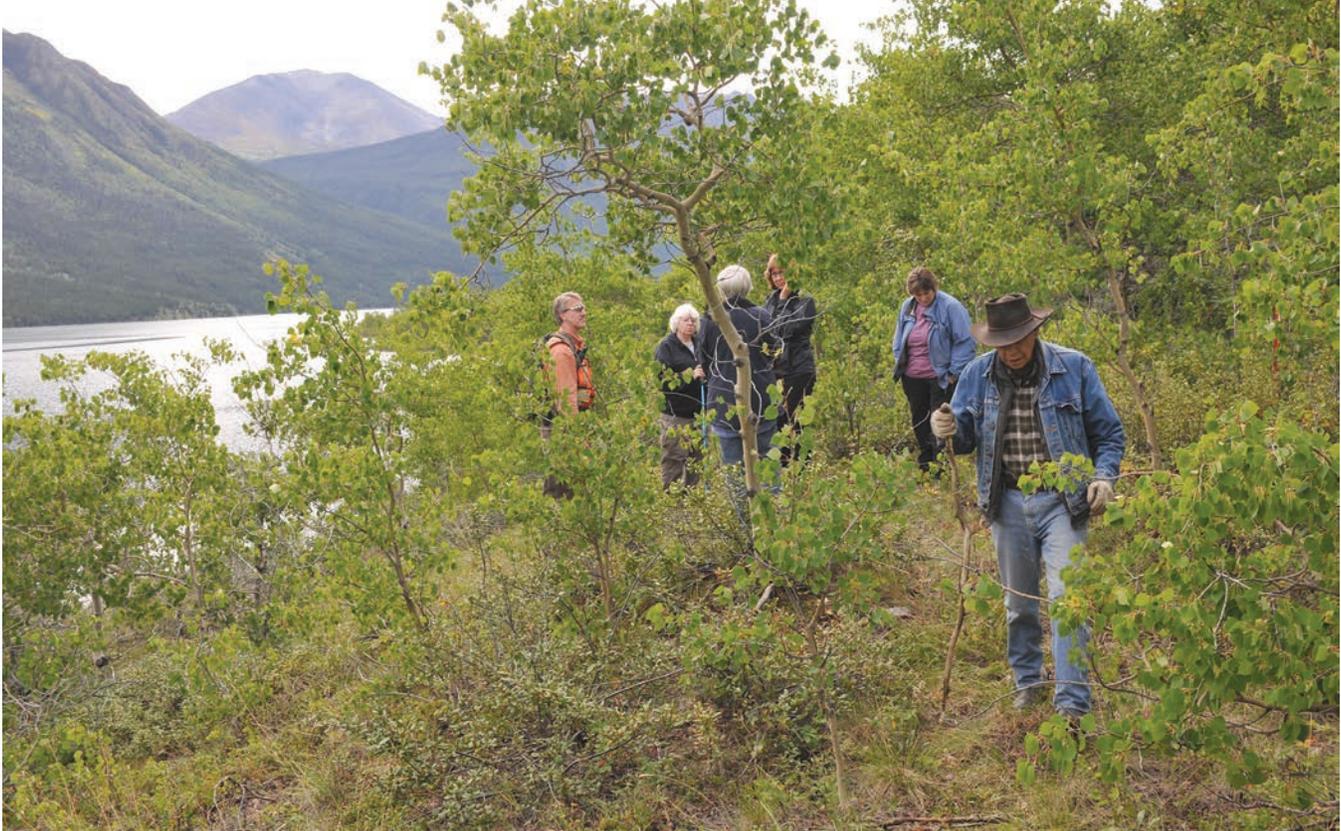
2.0 Planning Process

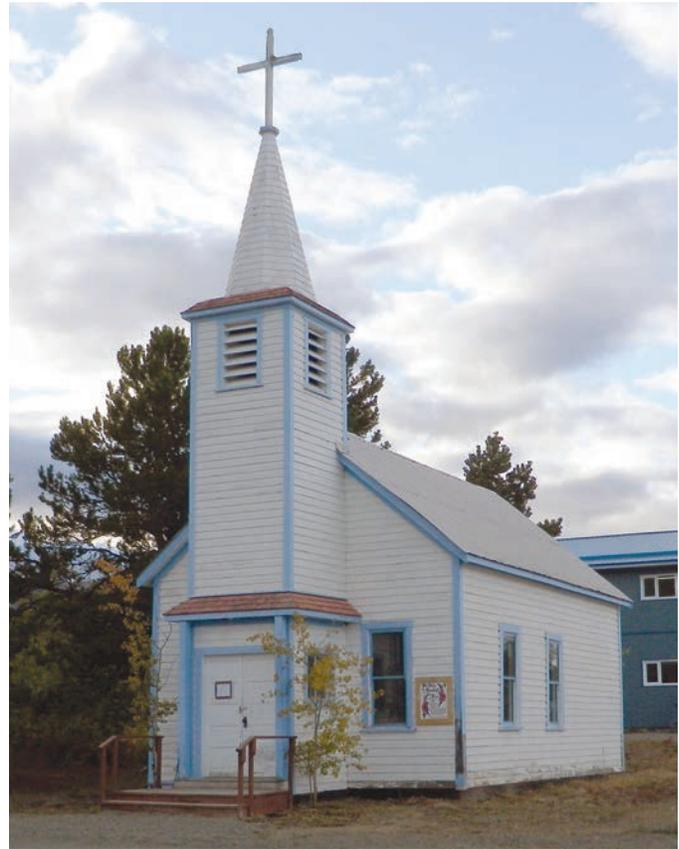
St. John the Baptist Catholic Church was brought from Conrad to Carcross in 1939.

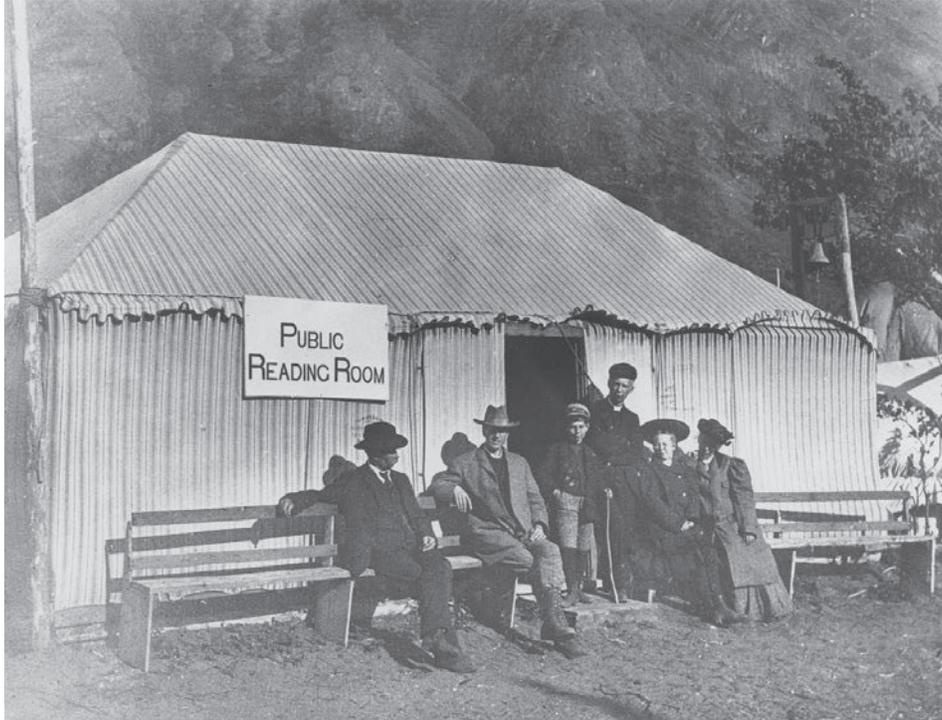
Public reading room run by the Anglican Church at Conrad, circa 1905.

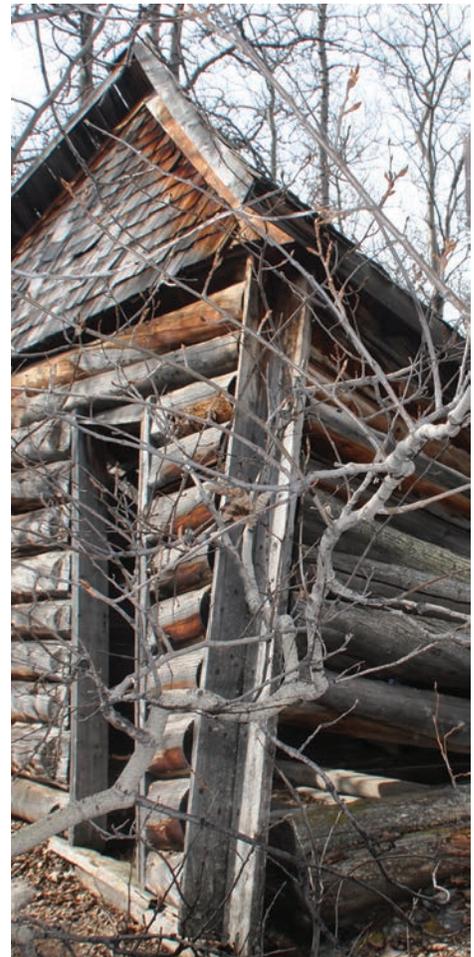
Example of a Yukon corner, Cabin 2.

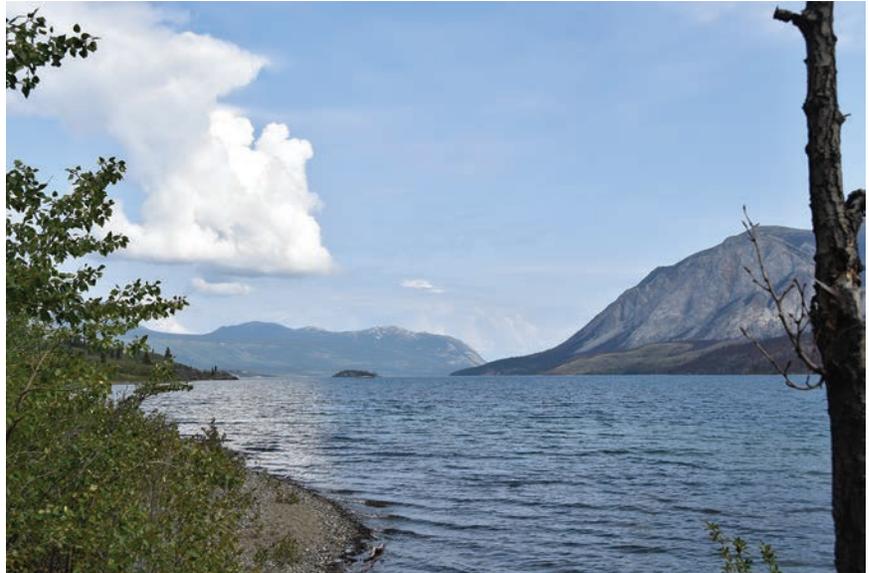
View of Windy Arm from Conrad Historic Site.

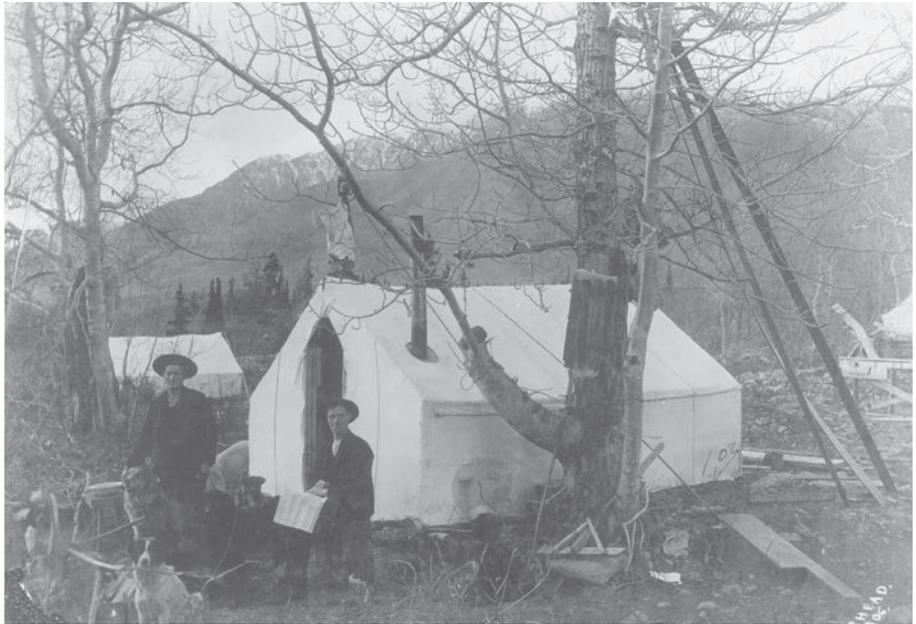
Conrad, 1906. A bag, probably containing food, is suspended above the tent doorway. YA, John Scott fonds, 89/31 #200

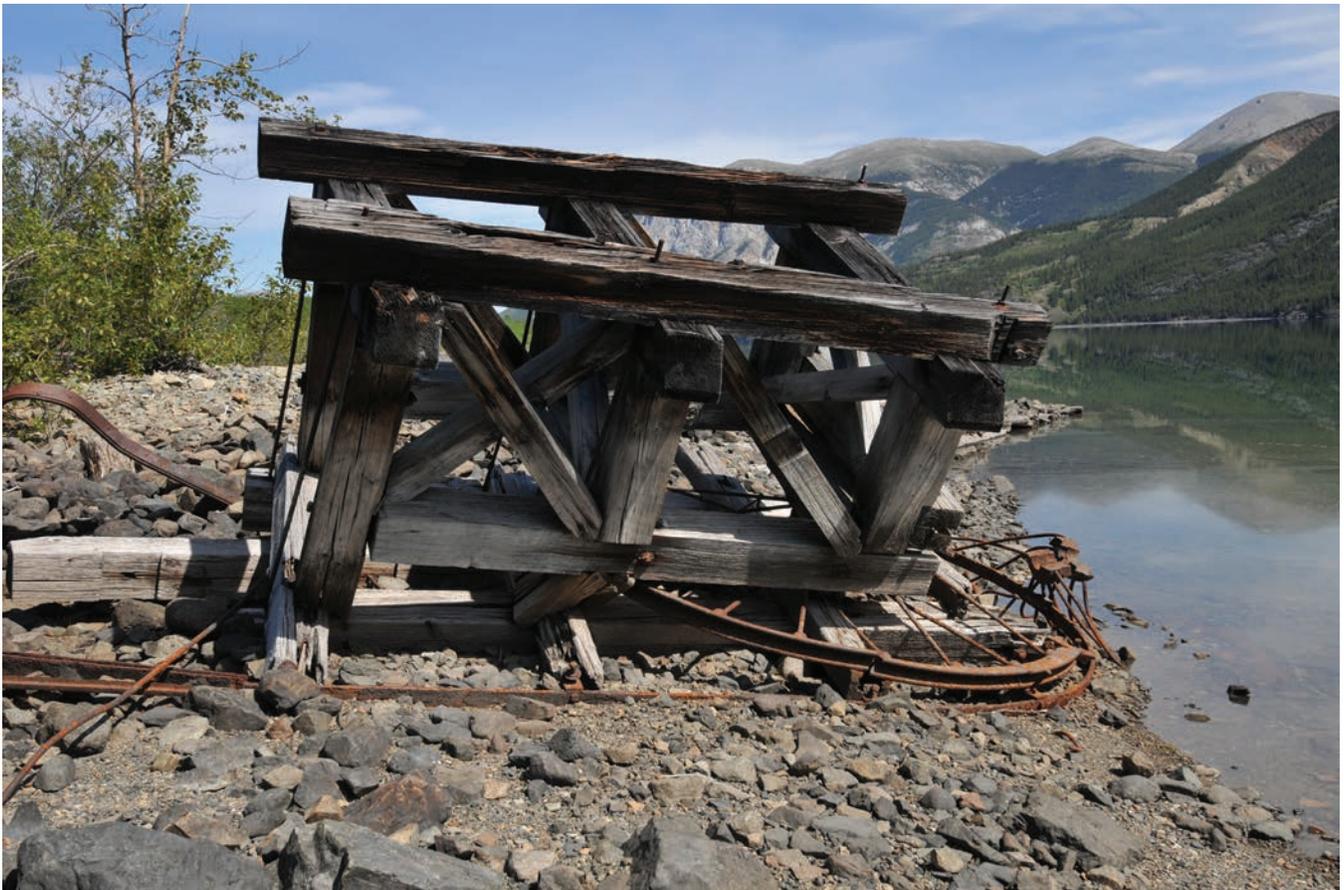
The Mountain Hero Tramway Terminal is a complex structure that is very incomplete at this time. Two large sections still exist. Both appear to be portions of the upper structure of the terminal. One appears to be in or close to its original location on or near the end of the wharf. The other has toppled to the southeast and sits in water when the lake levels are high. Both structures are composed of horizontal, vertical and angled Douglas fir timbers of varying sizes. The timbers are connected by bolts/ threaded rod, timber washers and nuts. In addition to the wood components and metal fasteners there are a variety of metal components used for the operational requirements of the tramway.

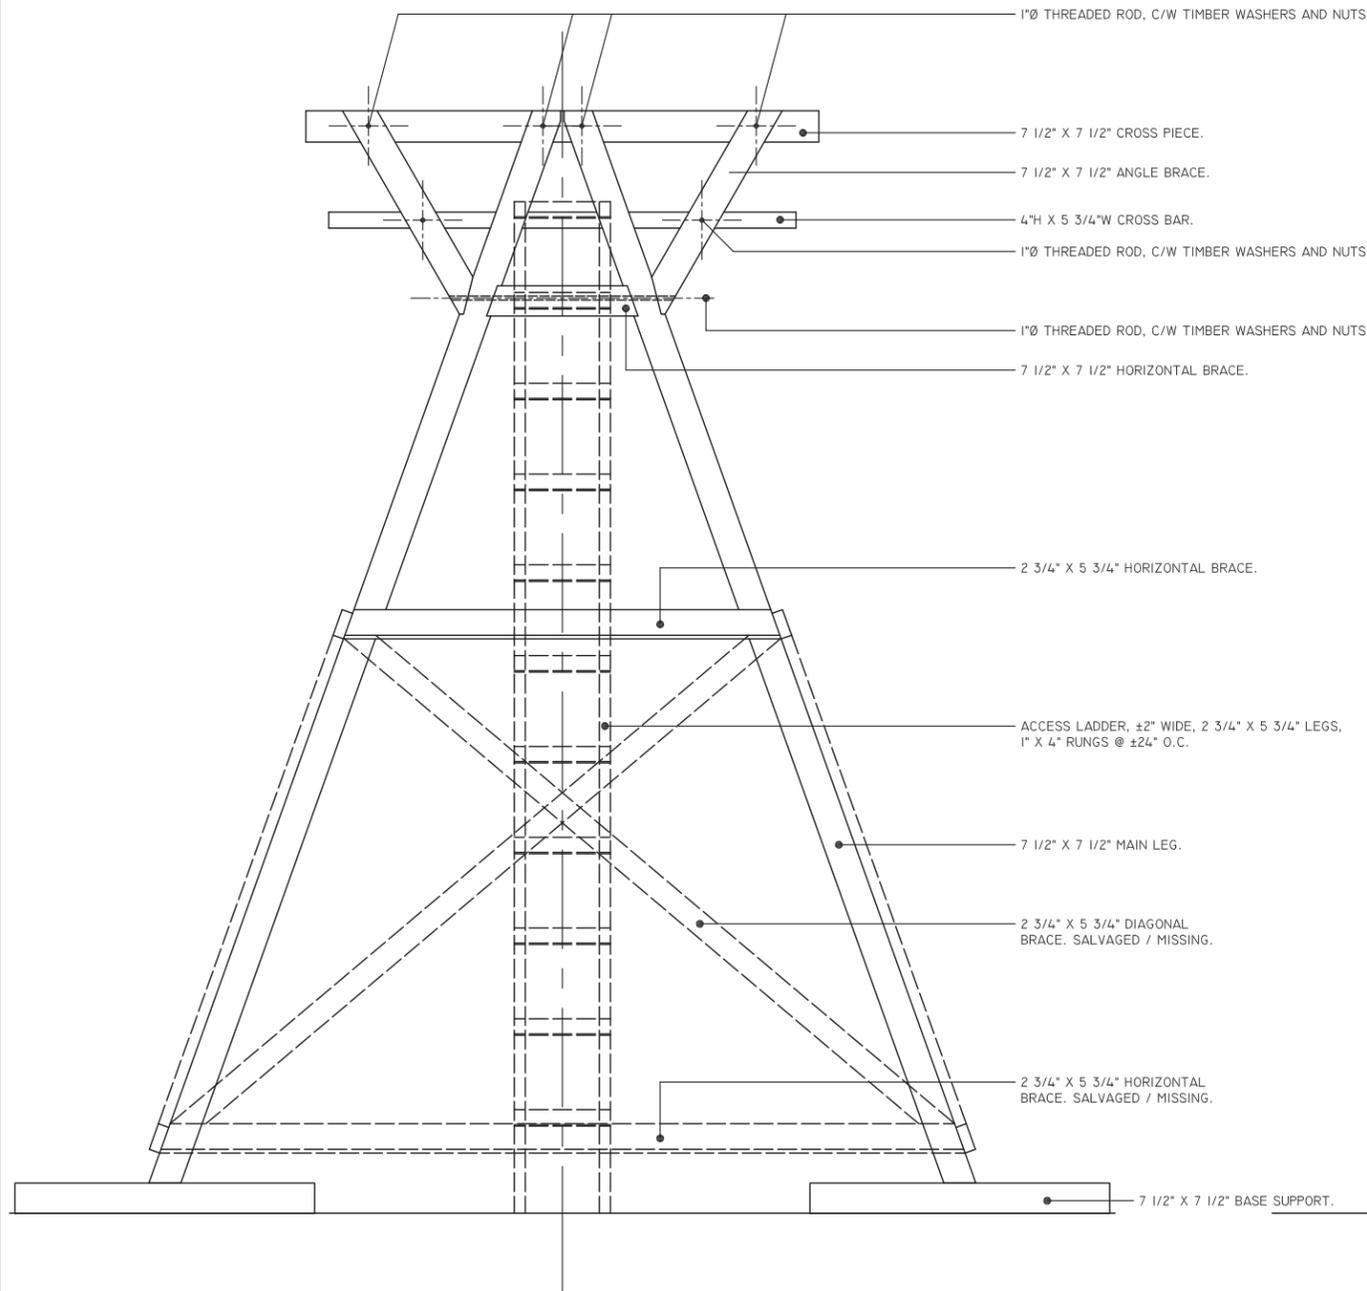
WEST ELEVATION (TYP.)

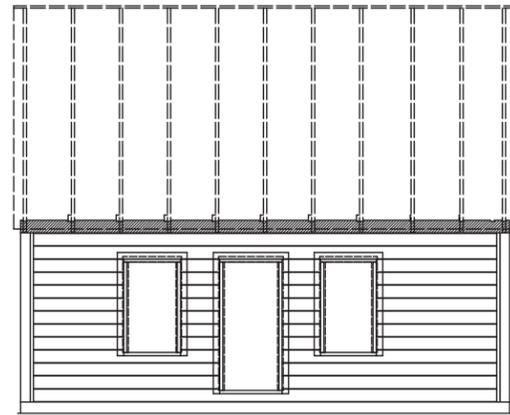
EAST ELEVATION
1 : 50

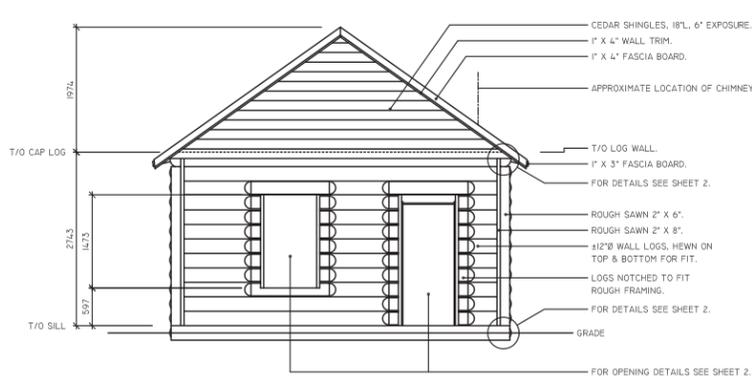
EAST ELEVATION
1 : 50

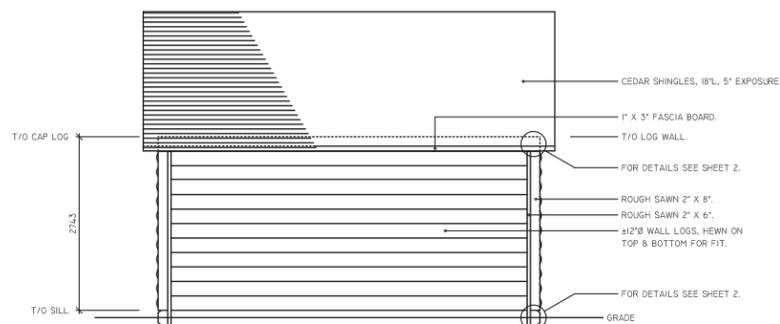
SOUTH ELEVATION
1 : 50

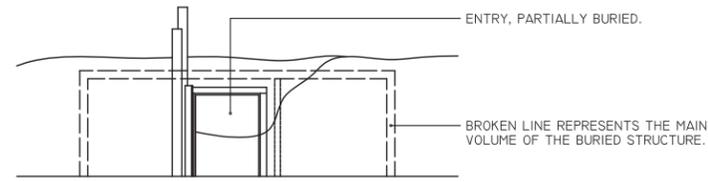
EAST ELEVATION
1 : 50

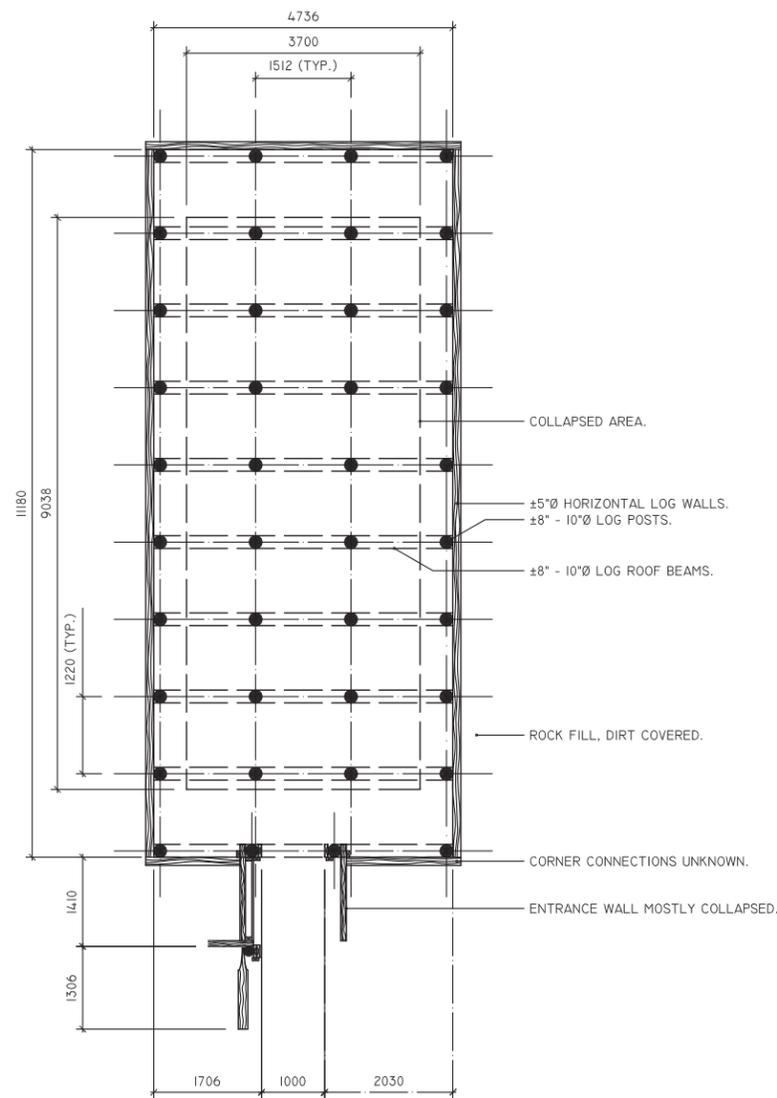
1. DO NOT SCALE FROM THE DRAWING.
2. ALL DIMENSIONS ARE IN MILLIMETERS UNLESS OTHERWISE NOTED.
3. THE LENGTH OF THE STRUCTURE IS APPROXIMATE ONLY DUE TO THE COLLAPSED ROOF AND THE INACCESSIBILITY OF THE INTERIOR TO OBTAIN AN ACCURATE MEASUREMENT.
4. THE STRUCTURE IS DRAWN AS IF THE ROOF HADN'T COLLAPSED. THE BROKEN LINE IS THE APPROXIMATE AREA OF THE MAJOR COLLAPSE. CONDITIONS AT THE REAR OF THE STRUCTURE ARE NOT KNOWN AS THIS AREA WAS NOT ACCESSIBLE.

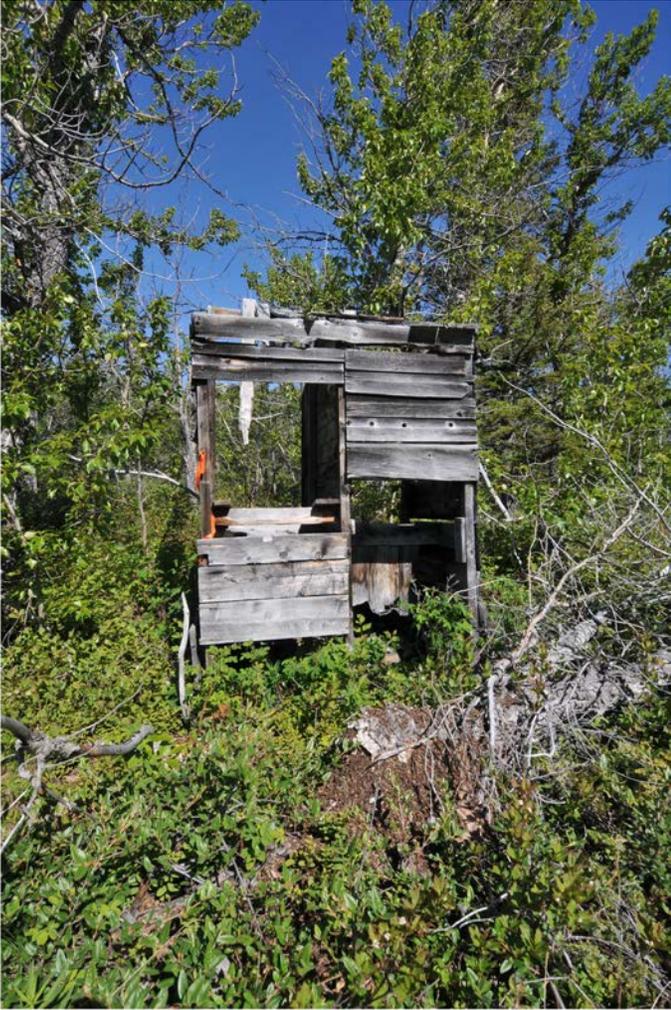
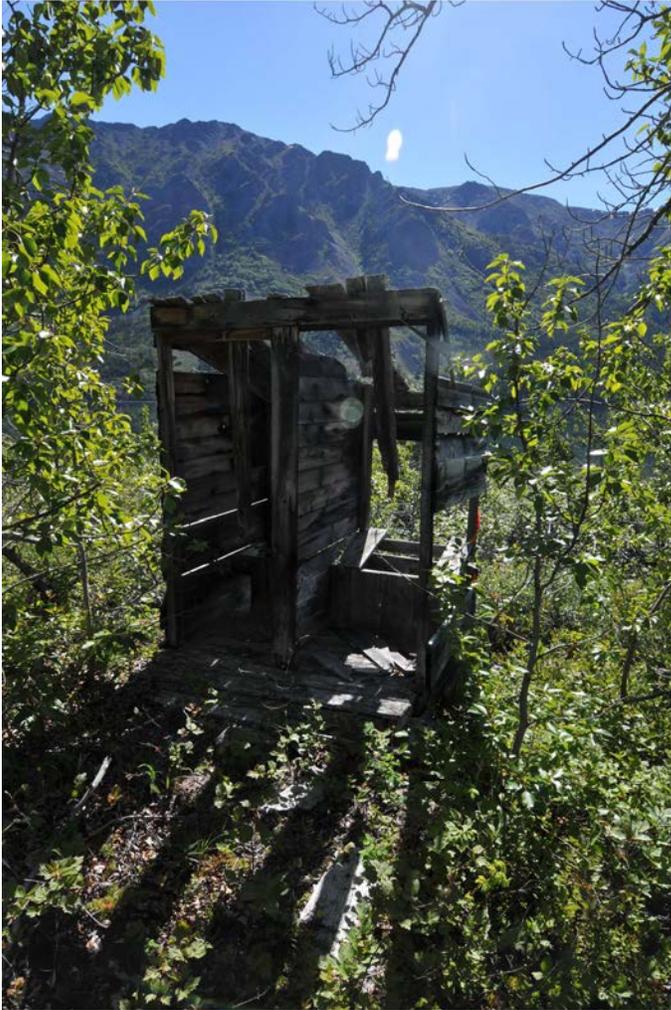
Outhouse (Two-Seat Outhouse)

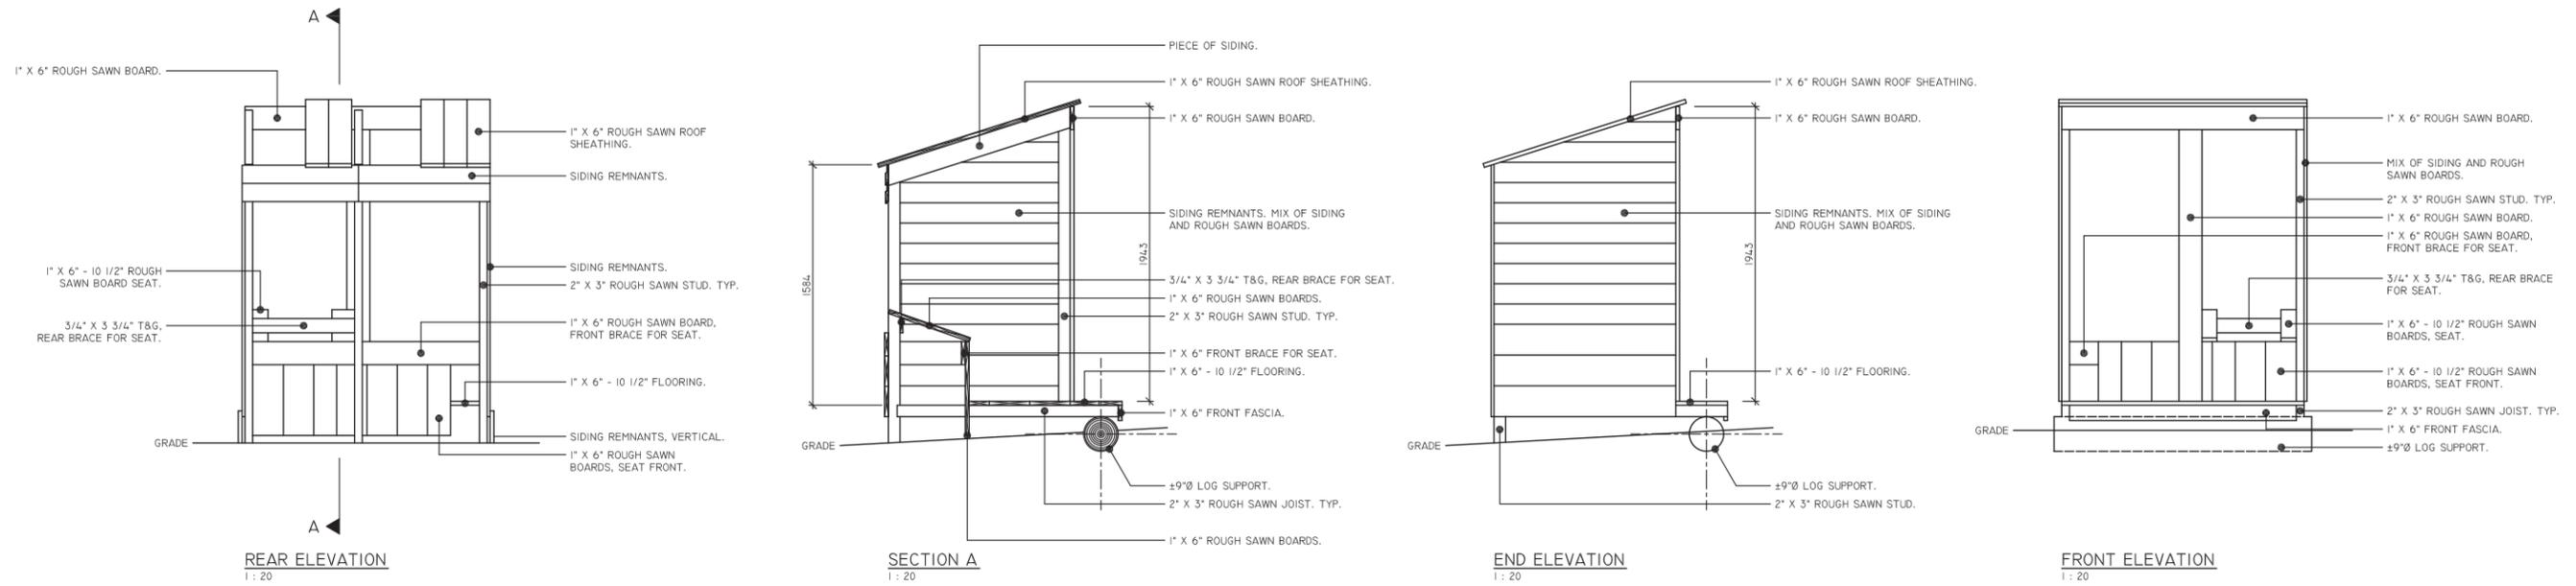
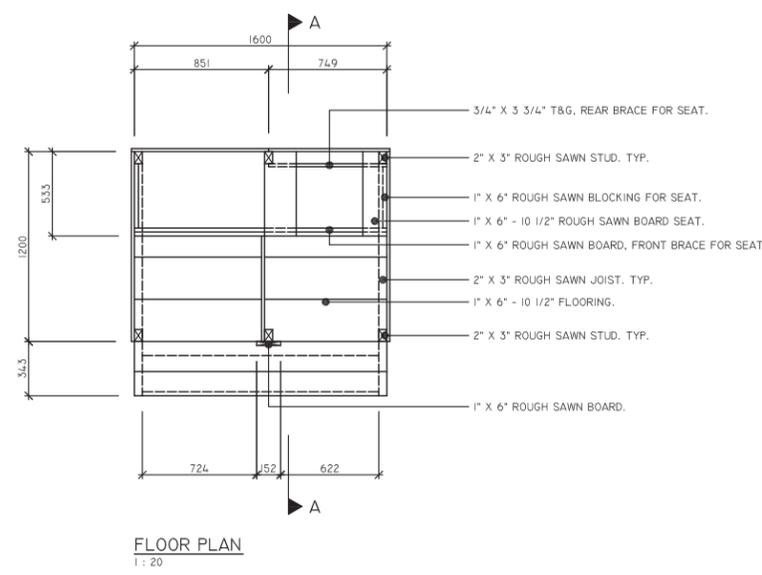
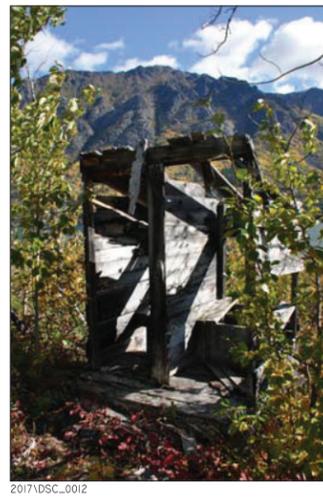
All of the wood components of this structure are weathered. No significant amounts of decay were observed, although decay will likely be found in those boards that are in ground contact, particularly on the uphill side of the structure.
