A PRESERVATION PLAN FOR  
FORT SELKIRK

JOHN KEAY, ARCHITECT  
ROBERT PATTERSON, P ENG.

JANUARY, 1992

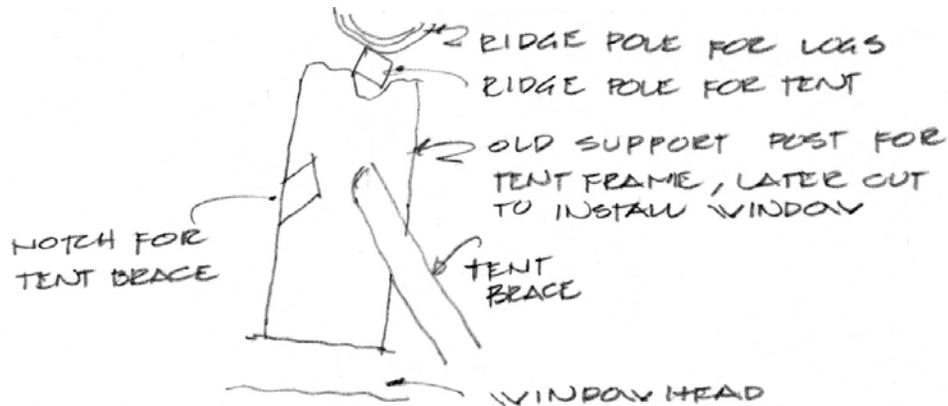
See sketch:

- Question appropriateness of using kerosene cans as temporary flashings.
- One of two converted tent frames. Cross bracing shows at each end, and has remnants of canvas attached.

- A second ridge beam was added when the canvas was covered over. The lag walls for the tent frame went to the fifth round, the canvas extended down to this height. The upper walls are made from logs & possibly recycled from another building, as they are notched in odd places. There are some remnants of wood crates and cardboard cartons nailed to the interior walls.
- Stove and chimney location to be confirmed from older photographs.

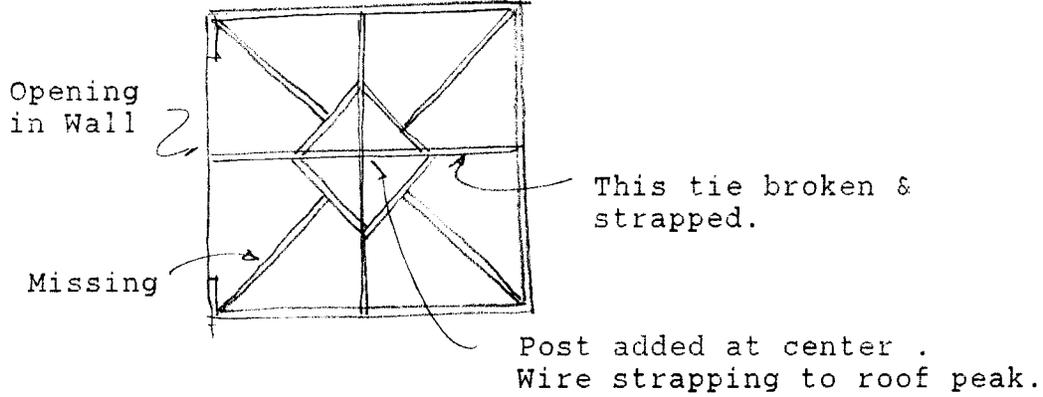
- Parts from other buildings to be stored elsewhere. -Note that the framing of the pyramidal shaped roof is different for each of the YFF buildings. The garage is as follows:

-The material from other buildings should be returned to them, as far as possible.

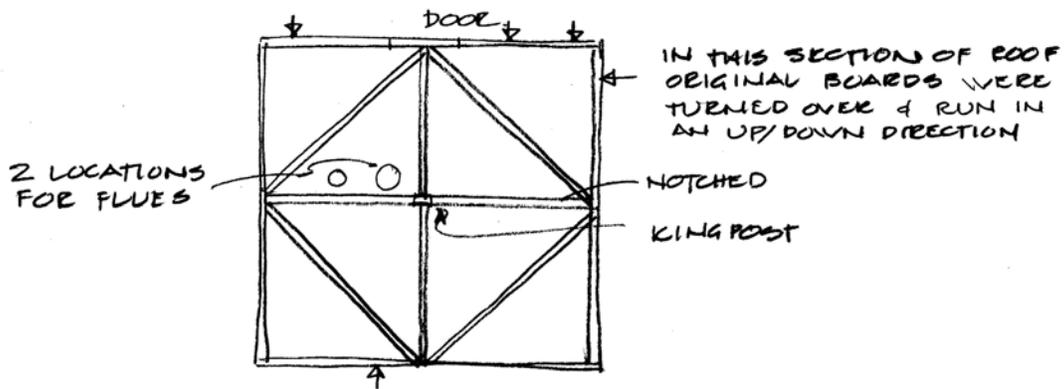
SKETCH

- Extensive wet rot in cellar (moisture problem)
- Front door trim too narrow - should be 1 x 8 - see traces
- Building has been lowered (during move), logs are numbered for re-assembly, (see drawing)
- Cardboard ceilings could be restored.
- Wood trim from this building presently stored in garage should be returned.

Log numbering locations = arrows

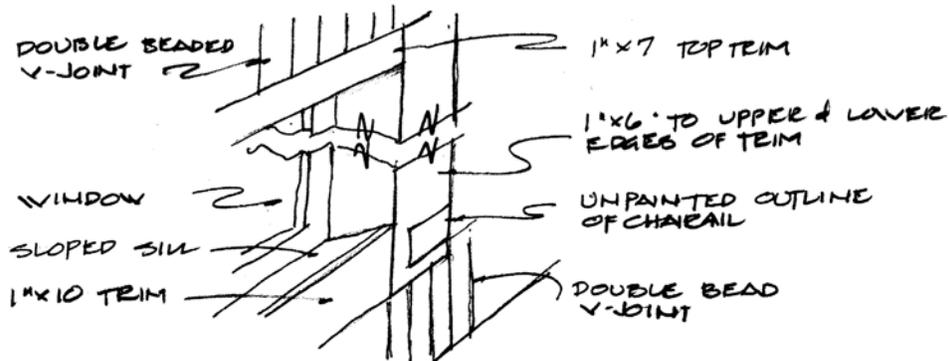
-V joint should be screwed onto permit periodic replacement of sill logs. See sketch of panelling.

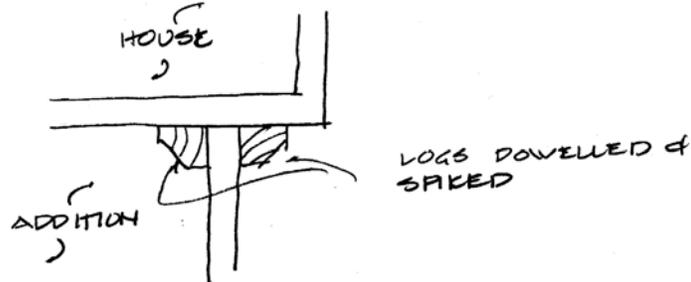
-Attachment of addition to main house:

-Basement is quite damp, showing wet rot spores.

-Doors starting to jam.

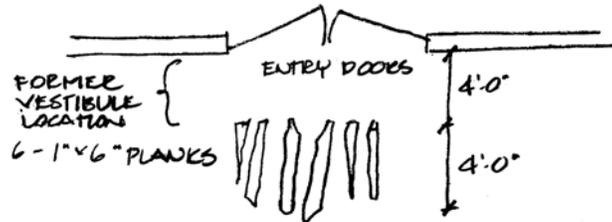
- The ledger support for the rear roof addition is a priority.
- The additions may have been constructed from YFF logs. Some logs on the "Club Room" addition are deteriorated and should be reviewed regularly. This addition is lag bolted to the main building-the correct approach.
- Remnants of boardwalk at front door.

- Sign at entry should be removed or replaced. There is evidence of another large sign. The correct size should be confirmed using archival photographs.

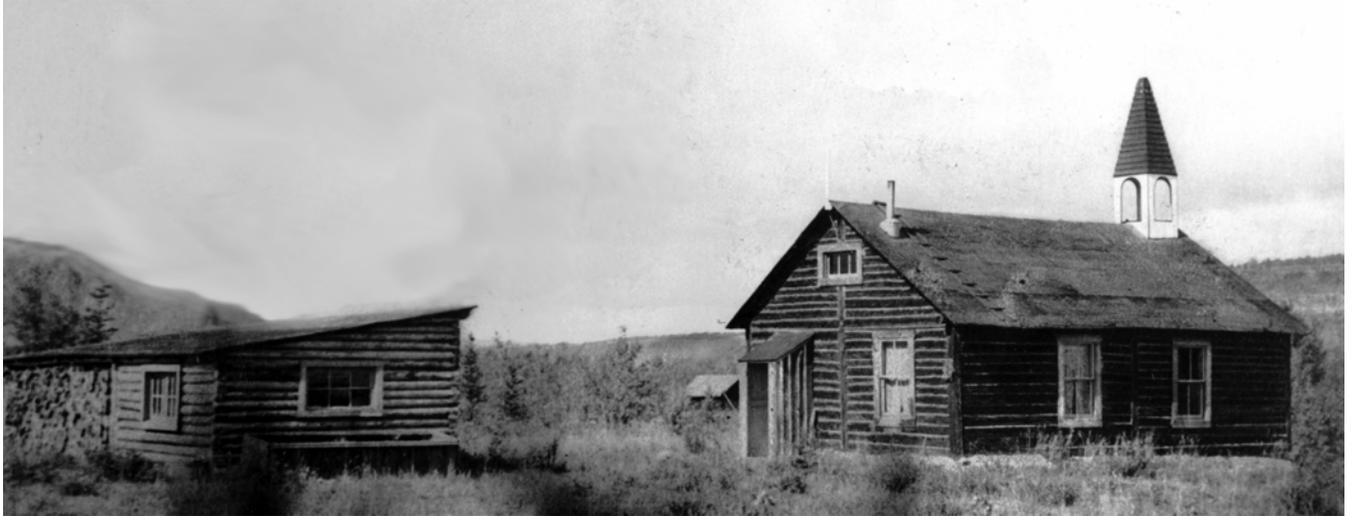
16. St. Francis Xavier Catholic Church, ca 1945, Father Bobillier Coll., 8723. The photograph was taken three years after the building was moved; the extent of backfill around the sill logs is clearly visible. The structure appears straight and level.

- Window replacement in 1942 (larger windows) may have weakened the building
- See appendix re stabilization report -Cellar dry & well vented .
- Upper floor - should be closed off, note the extra arches for the original larger nave.
- Note that in the northwest corner of the west wall, the piece-en-piece construction uses a spline, instead of tenons.

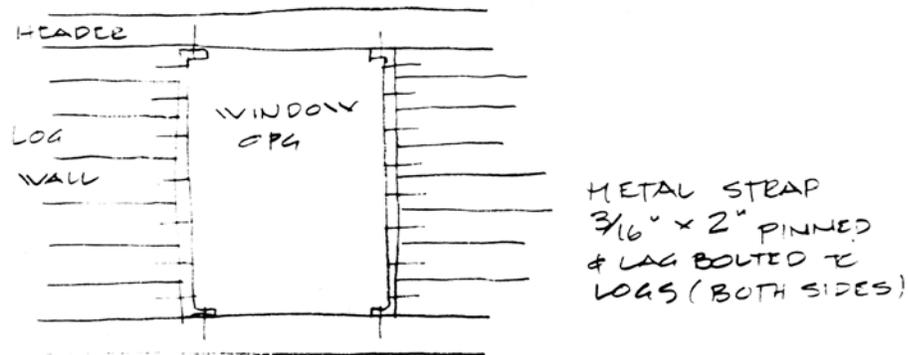
The Church is at present showing some signs of distress, particularly in the uneven deflection of the sidewalls and in the apparent outward movement of the corner posts. The latter is such that the tenon is almost out of the mortise on the lower logs, and has in fact had a filler piece added at the northeast corner. This movement is likely caused by the deterioration of the short lengths of 12 x 12 sill timbers, resulting in differential settlement and movement of the logs during freeze/thaw cycles.

In addition, the east and west walls are bulging outward in the vicinity of the enlarged windows which were installed in 1942.

This may be due to inadequate fastening of the sidewall logs to the rough framing for the window. It is recommended that the window casings be carefully removed and the fastenings checked. Additional fastenings, possibly by means of a vertical steel plate, may be required to tie the log ends together. If this plate is installed, it should have the ends bent to accommodate lag bolting to the through logs above and below the window.

A stabilization program should include the following:

- 1992: the exterior walls should be carefully measured and these dimensions recorded on a monthly basis. If there is any sign of outward movement, the building should be protected as necessary, and then wrapped with a cable which can be cinched up to prevent any further spreading of the lower logs
- 1993: the sill logs should be replaced. Logs should be one piece, as has been done elsewhere on site. Particular attention should be paid to the grades around the building, using the YWS drawings and the archives photograph. As part of this process, the corners should be drawn together, and the building straightened.
